SEVERAL SUBJECTS STILL REMAINED SINCE THE 1995 KOBE EARTHQUAKE

Abstract: The 1995 Kobe earthquake brought serious problems from the earthquake disaster mitigation point of view. In this paper, several important subjects will be discussed after reviewing what happened during and after the earthquake. Most of all, the following subjects will be discussed in this paper.

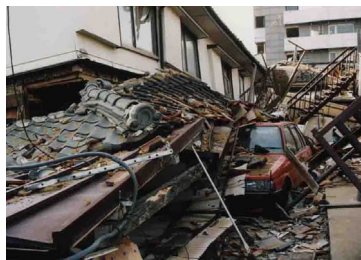
Most of residential people were in bed during the earthquake, and crashed in such condition as shown in Photos.1-3. Urgent rescue activity might be very hard because of the condition like Photos.2 and 4. Every transportation system was quit including JR Super Express (Shinkansen) as Photo.5 and Hanshin Highways as Photo.6. Therefore the only way was just to walk or to take bicycles or motorbikes as shown in Photo.7. Fortunately there were no big aftershocks, but local governors and polis men did not control the people passing through very dangerous areas like Photo.8. Residential people made temporal evacuation mainly into neighboring school buildings (Photo.9). But the term of temporal evacuation continued for a few months or several months. After they moved to temporal houses those were prepared by local governments, they had to live there for five years in maximum. Residential people living around the foot of Rokko Mountains had to repeat quick evacuation when the weather forecast predicted heavy rainfall. As Photo.10 shows such condition, it took almost two years to have completed Sabo-protection.

Photo.1 Typical example of collapsed wooden houses (Nishinomiya)

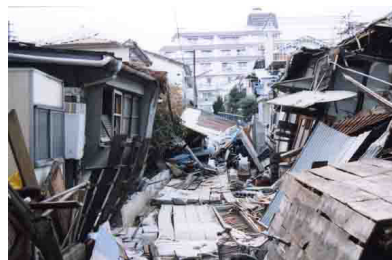
Photo.2 Collapsed houses disturbed rescue activities (Uozaki, Kobe)

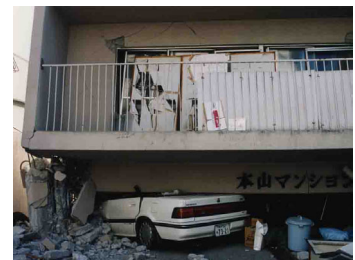
Photo.3 Soft first story suffered heavy damage in many places (Motoyama, Kobe)

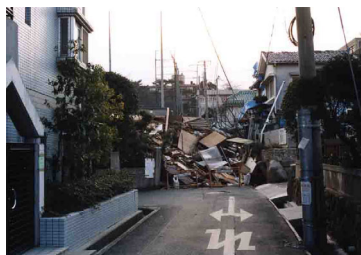
Photo.4 Such condition even after a couple of months (Uozaki, Kobe)

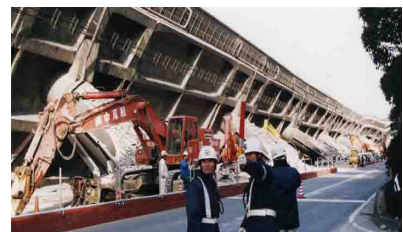
Photo.6 Overturning failure of Hanshin Highway (Fukae, Higashinada, Kobe)

When we were thinking about the failure direction of damaged structures mentioned above, Kobe No.3 of Hanshin Highways (Photo.6), overturned toward the north direction with more than 600m in length, was one of targets to be taken into account. At first we believed that it must have collapsed quite soon during the strong shaking, and we estimated that the failure had been triggered at the west end and transmitted toward the east following to the seismic wave propagation from the source. Then we wanted to find people just watching the failure because no other information was expected. But we hesitated to ask neighboring people about this matter, as they did not like remembering the catastrophic condition anymore.

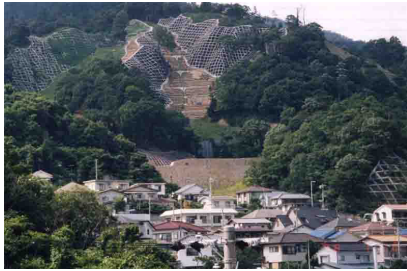
Photo.10 Land failures protected after two years (Sumiyoshi-Yamate, Kobe)

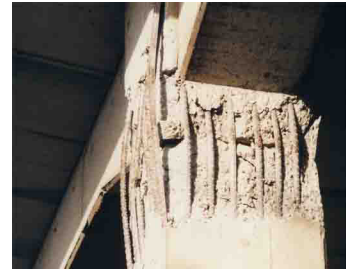
From earthquake engineering point of view, JR-Shinkansen exposed its vulnerable circumstances, in some case because of exceedingly heavy structure (Photo.11) and in another most of cases because of lack of binding hoops at the top of columns (Photo.12). It took four months to start working by repairing those columns like Photo.13. The other ordinary JR and private railways also suffered heavy damage mainly in embankment parts. Take Photo.14 for instance, it shows a very clear contrast between the enforcement of collapsed Hankyu railway (left) and remaining old houses without damage (right). Hanshin Highways were very quick to have reconstruction. It took only 20 months to have the condition as Photo.15. We remember that there was a very serious discussion about Embarcadero Freeway in San Francisco after the 1989 Loma Prieta earthquake, whether it should be reconstructed or not. Unfortunately there was no time for discussion in Kobe, although there was another opinion to abolish it.

Photo.12 Failures of the top of columns in JR (Nishinomiya)

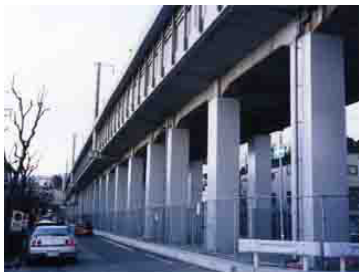
Photo.13 JR-Shinkansen after temporary repairs (Nishinomiya)

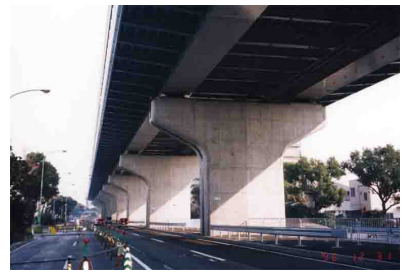
Photo.15 Restored Hanshin Highway after 20 months (Fukae, Kobe)

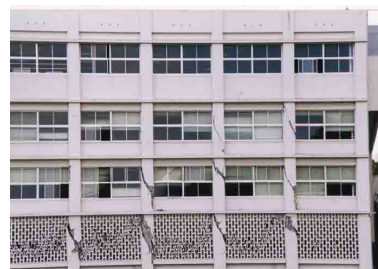
Photo.16 One directional shear failure of a school building (Okamoto, Kobe)

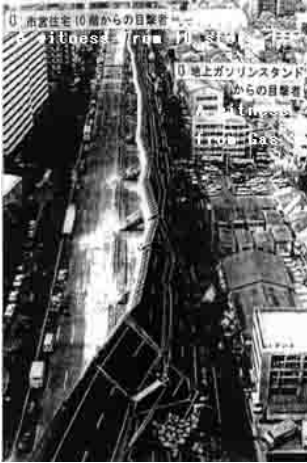
After all we started the survey in 2001, after 6 years from the earthquake. We found two persons who were watching the failure by checking reliabilities very carefully. One person was working in front of gas station located just on the northern side from the highway (Photo.19). According to his explanation in our interview, he fell and landed during the strong shaking, and was watching the behavior of the highway. At that time the highway was shaking without falling down. After a couple of minutes from the strong shaking, the highway started falling down against his side (north) from the west toward the east grading up the speed. He also found an empty truck had landed from the highway to the ground level and run away.

Photo.19 Overturning failure of Hanshin Highway and the location of watchers

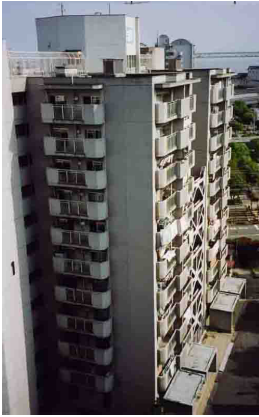
According to the results of our questionnaire to living people, the older building suffered much heavier damage than the newer one. For example, the people in the older building felt much harder shaking, suffered heavier damage on furniture, heavier cracks including seismic walls and around entrance steel doors. Therefore they could not open the doors for evacuation. Such people had to stay much longer duration in other evacuation places because it looked very dangerous to live there (Fig.14). The local government repaired these buildings without moving the living people using additional seismic walls on the ground level. The steel frames mentioned above were put only for the older building, because the government judged the damage of the older one looked much harder although they were not sure such countermeasures were good enough or not.

Then we made a comparison of these two buildings using measured ambient motions on the top of both buildings. Some of measured dataset was quite interesting to explain their dynamic behaviors. The natural period of longitudinal direction was about 0.60s for both buildings. It meant that the steel frames of the older building worked well to have similar characteristics with the newer one, and such natural period looked quite reasonable for general RC-building with 11 floors. In the rectangular direction, the older building showed much longer natural period as 0.54s, while the newer one showed

0.48s. It was also reasonable that the older building might be softer than the newer one, maybe due to the different building code. After the enforcement with steel frames for the older building, it became much easier to have torsions. As we have just examined such features with only ambient motions, we recommended the local governors to make more careful surveys for both buildings. They should have made such surveys just after the earthquake or at least before the repairs.

Photo.20 RC-building built with the older building code

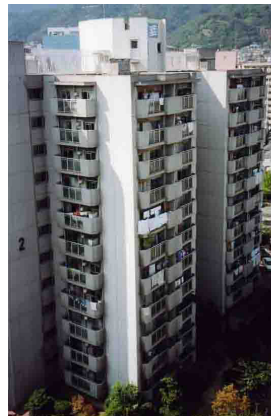
Photo.21 Similar building built with the newer building code
