# CUEE Report 2011-1

## **EARTHQUAKE RECONNAISSANCE SURVEY IN NEPAL OF THE MAGNITUDE 6.9 SIKKIM EARTHQUAKE OF SEPTEMBER 18, 2011**

### **Field Investigation Report**

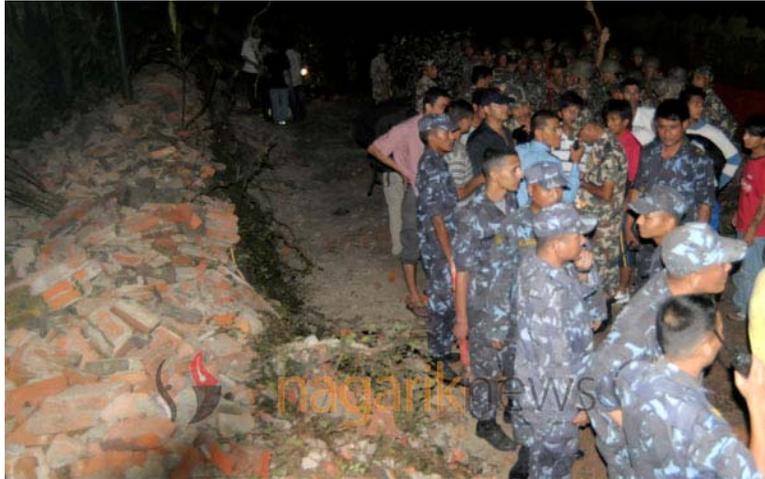
Fig. 2.2. Collapsed boundary wall of the British Embassy in Kathmandu where three people were killed (source: [nagariknews.com](http://nagariknews.com)). High length-to-height ratio might have resulted in the out-of-plane failure of the wall.

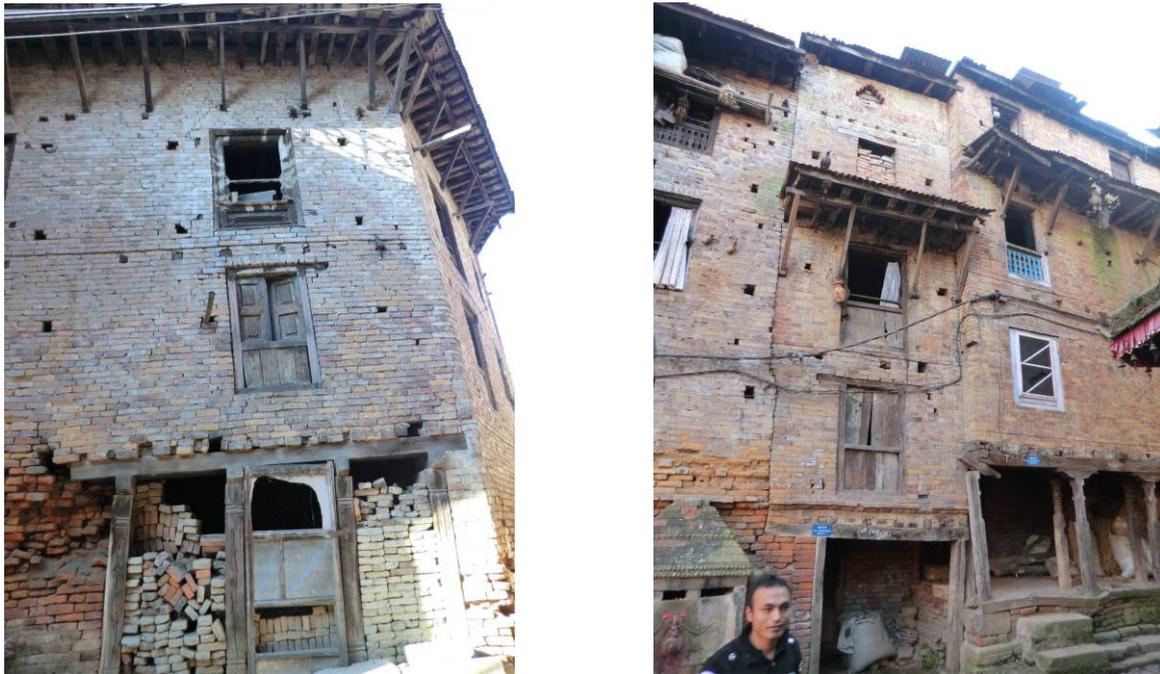
Fig. 2.3. Buildings in poor-condition, partially resting on timber frames, which did not suffer serious damage.

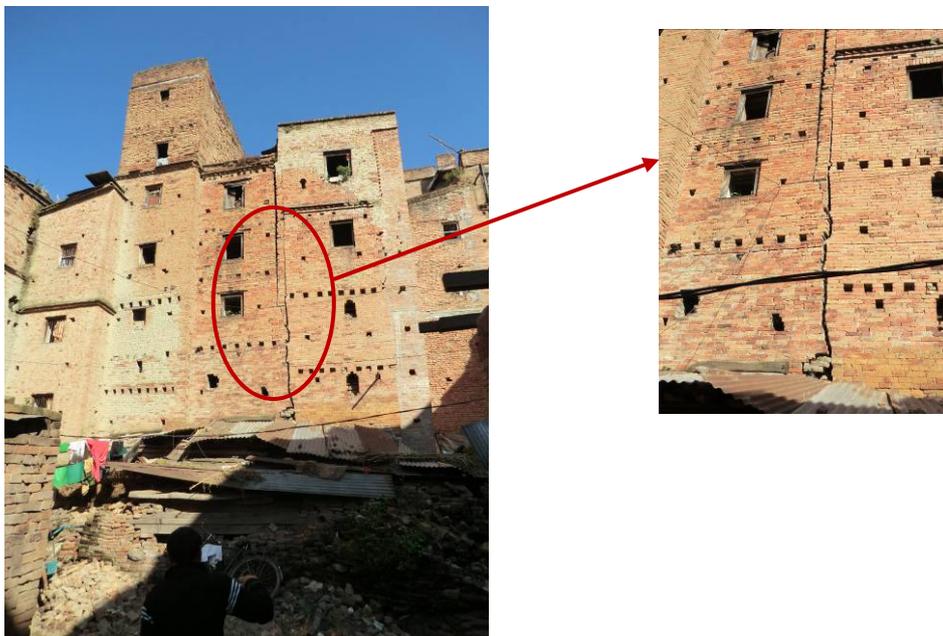
Fig. 2.4. Buildings with vertical cracks on wall along the mortar joint at the common face between two adjacent buildings. The figure also depicts several buildings in a block with shared common walls. Construction material is brick with mud mortar, while the structural system is partial-load bearing.

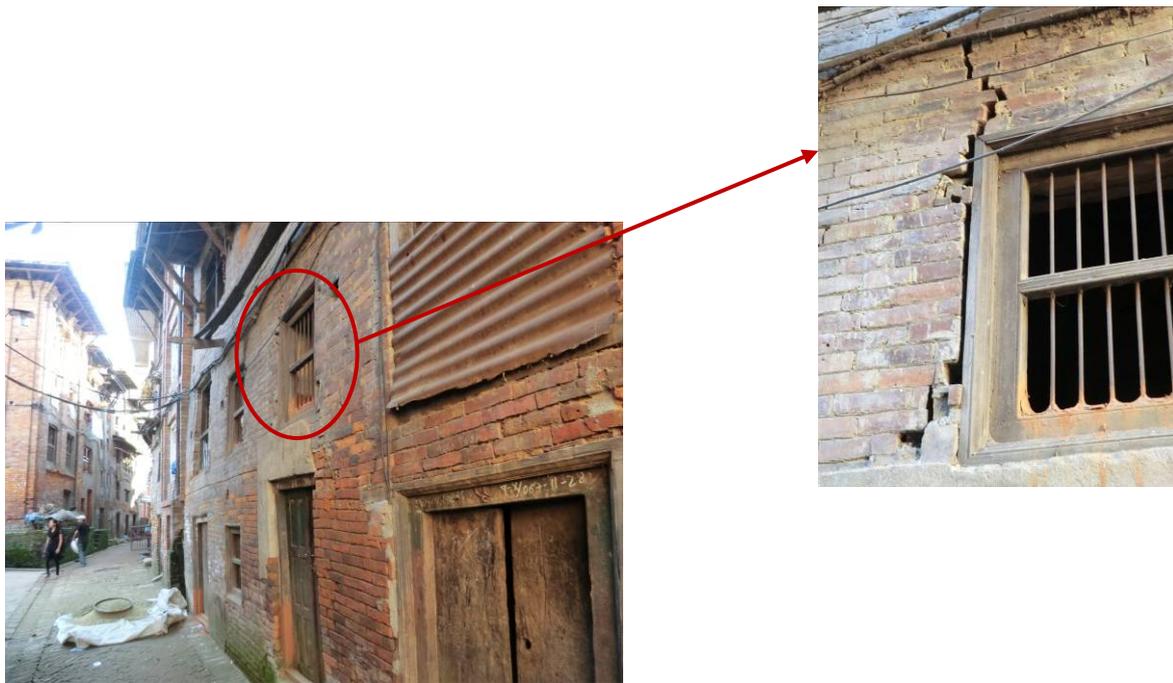
Fig. 2.5. A building with cracks starting from the interface between window and masonry wall. Cracks could also have propagated from the corner of lintels. The figure also shows permanent out of plane deformation of walls, which has resulted due to self weight of the building itself, prior to the earthquake.

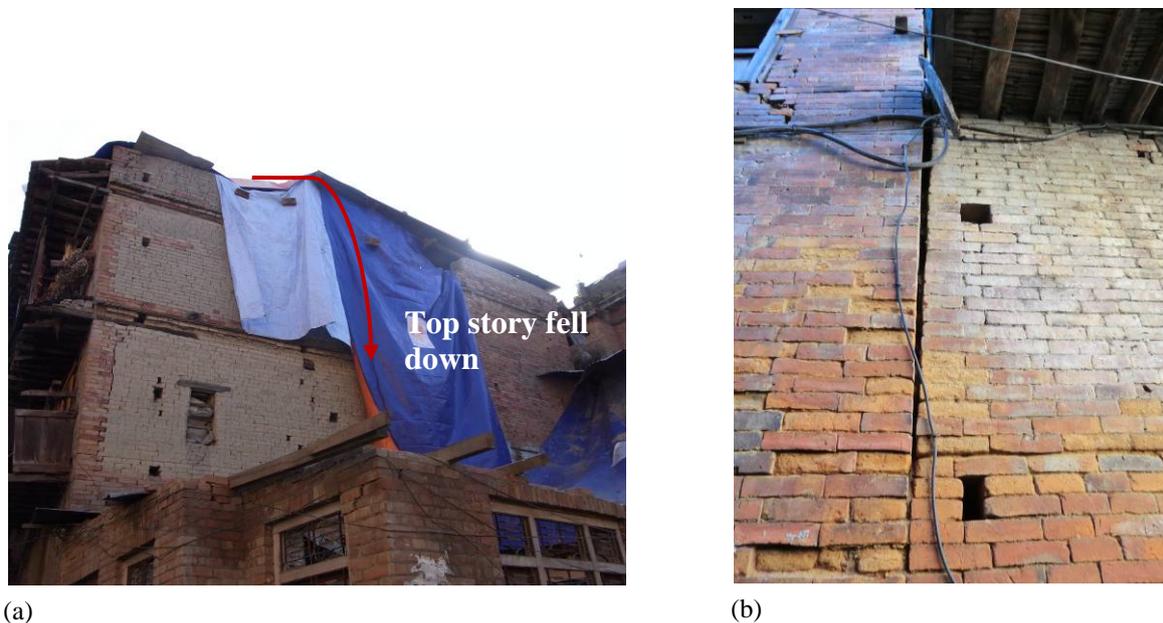
Fig. 2.6. (a) Top story of the left building (brick masonry with mud mortar) collapsed on to the roof of a building (brick masonry with cement-sand mortar) under-construction, leading to the collapse of the roof of the latter. The age of the existing building is 60 years. (b) Separation between two buildings due to the earthquake. The building on the left is made of the *first-class brick*, while that on the right is made of the *second-class brick*. Pounding between adjacent buildings could also have exaggerated the separation.

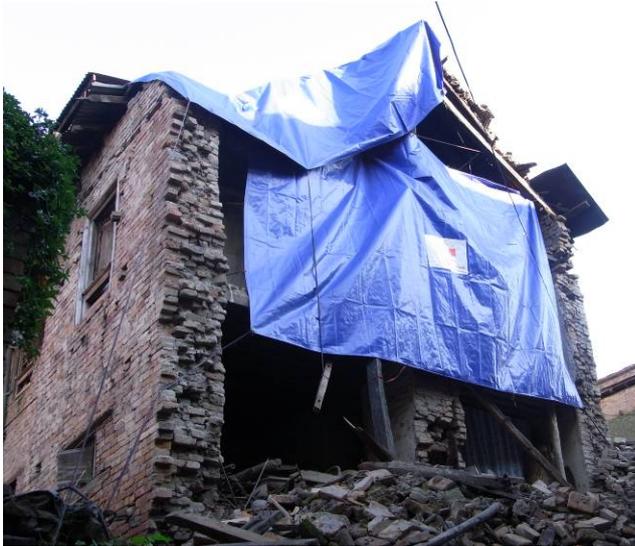
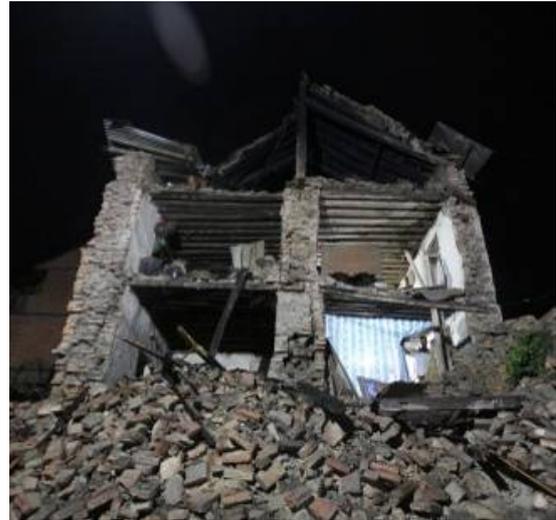
Fig. 2.7. A brick masonry building with a totally collapsed side wall: (a) photo taken by the investigation team on October 12, 2011 and (b) photo taken by the news reporters immediately after the earthquake (source: <http://www.mysansar.com/>).

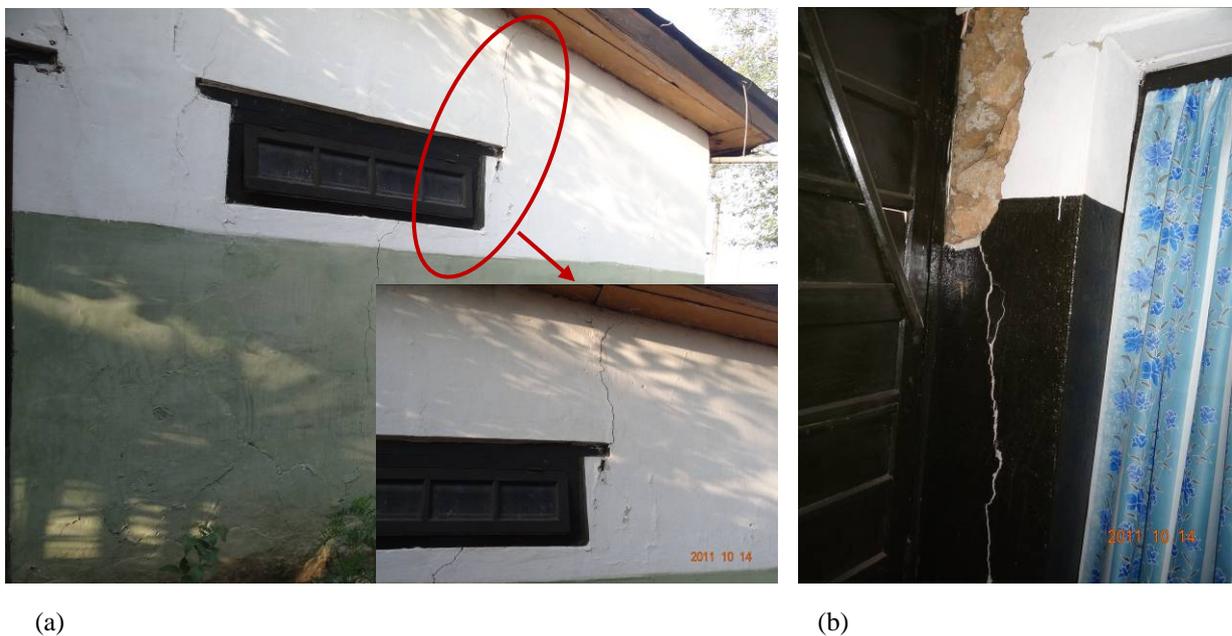
Fig. 3.3. A damaged single-story load-bearing stone masonry (mud mortar) building: (a) with cracks initiating from the interface between window and wall and (b) with cracks inside the building. The age of the building is 30 years. The wall thickness in the building is 450 mm, while depth of the foundation is 1.2 m.

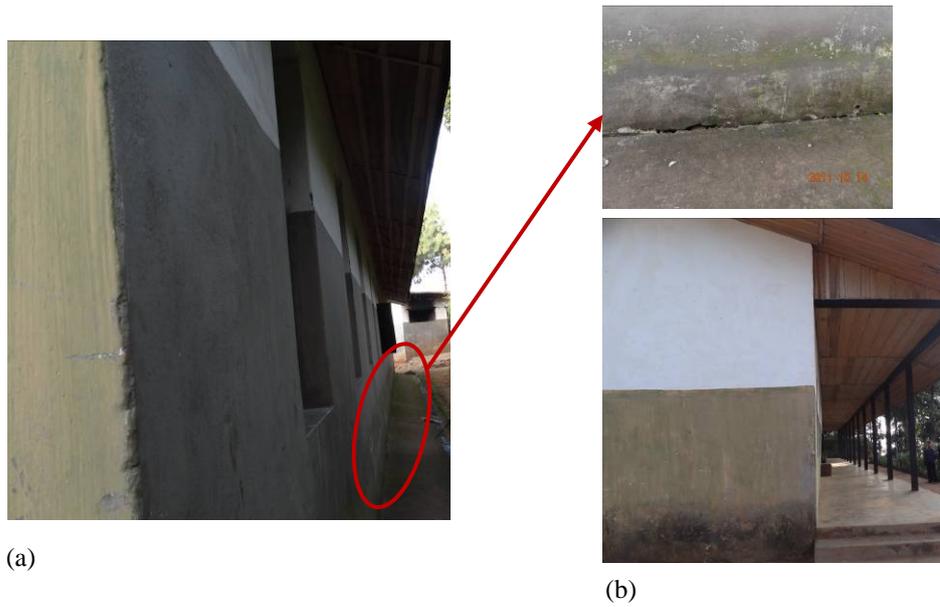
Fig. 3.4. A damaged single-story load-bearing stone masonry (mud mortar) building: (a) with permanent out-of-plane deformation of back wall and cracks at the base and (b) with permanent out-of-plane deformation of front wall. The permanent deformation at a portion of front wall was about 5 cm. The building has a length of 36 m and width of 7.2 m with no interior partition walls. High length-to-width ratio of the building resulted in the damage. The false ceiling fell down during the earthquake. Although, the building is being used at the moment, the owner plans to demolish it.

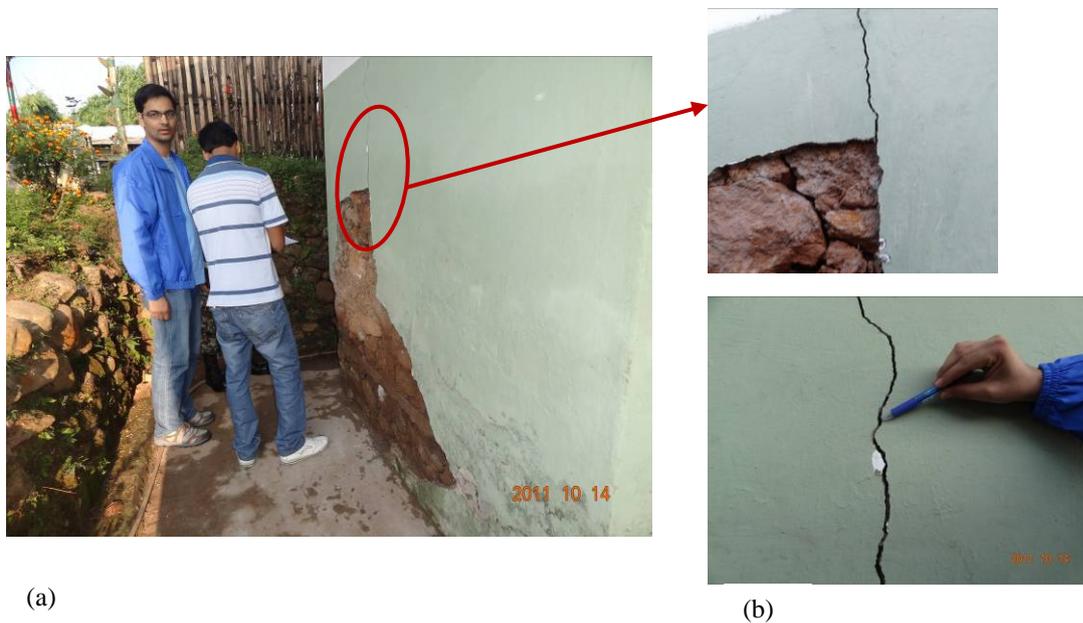
Fig. 3.5. A damaged single-story load-bearing stone masonry (mud mortar) building: (a) with plaster fallen down and (b) severe cracks extending throughout the thickness of the wall. Although, the building is being used at the moment, the owner plans to demolish it.

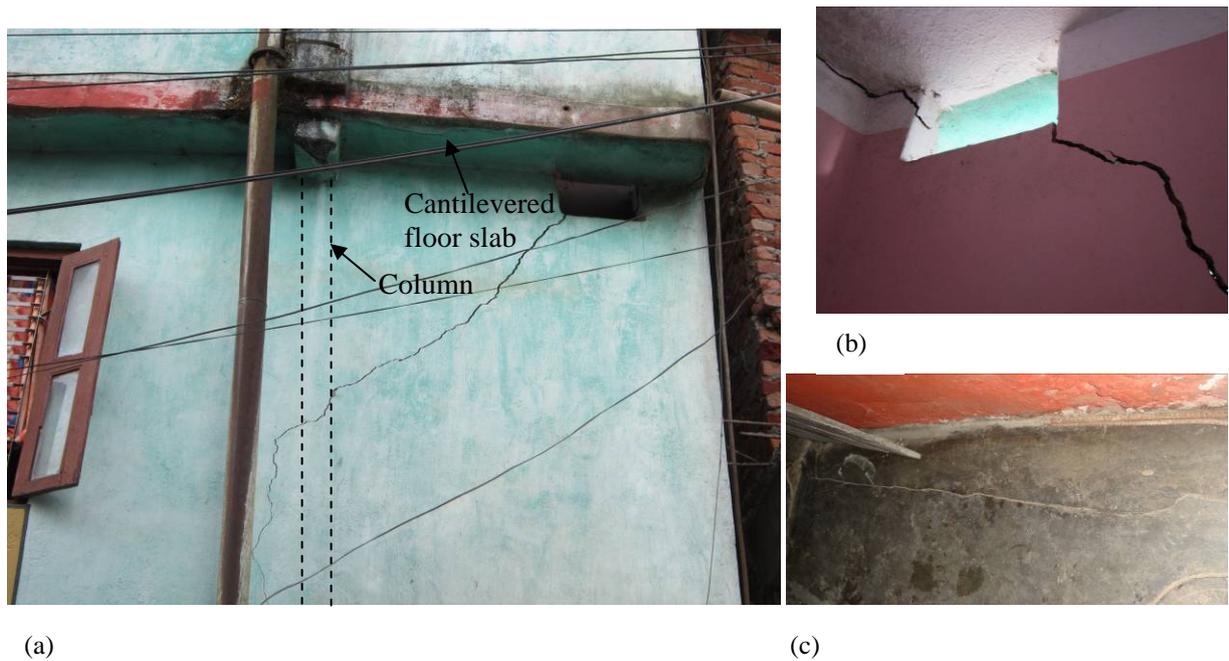
Fig. 3.6. A damaged modern 3-story RC framed building with cantilevered floor slab and brick masonry infill walls: (a) with cracks in exterior; (b) with cracks in interior; and (c) cracks on the floor along the edge of underground water tank/ septic tank.

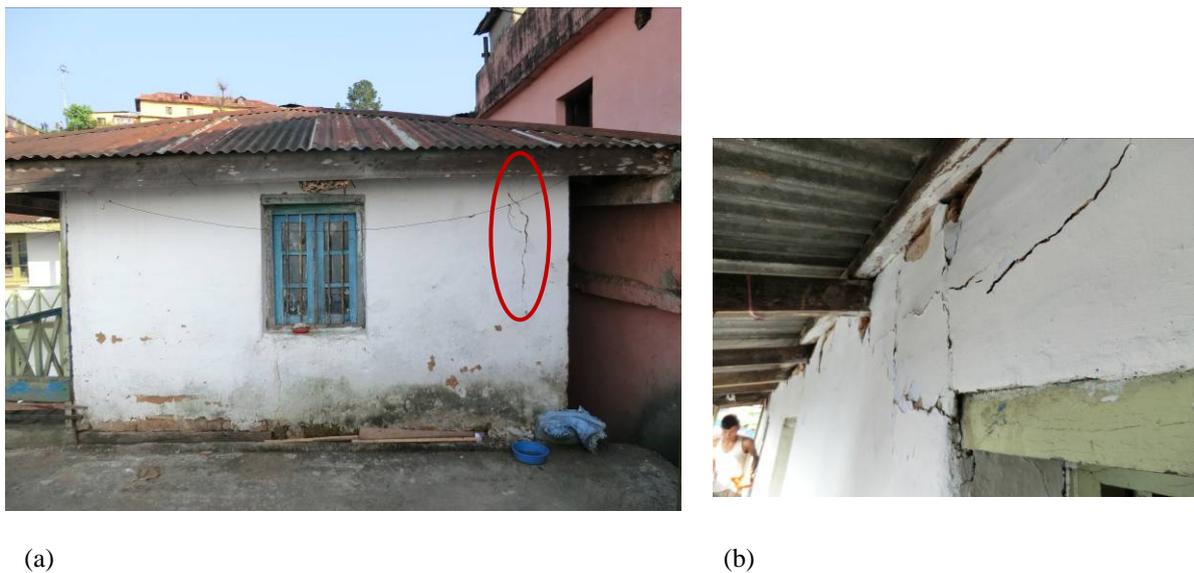
Fig. 3.7. Damage to a single-story L-shaped brick masonry (mud mixed with cow dung and rice husk mortar) building: (a) cracks in a wall and (b) cracks above the door lintel. The roof and partition walls are made of timber. Age of the building is 35 years.

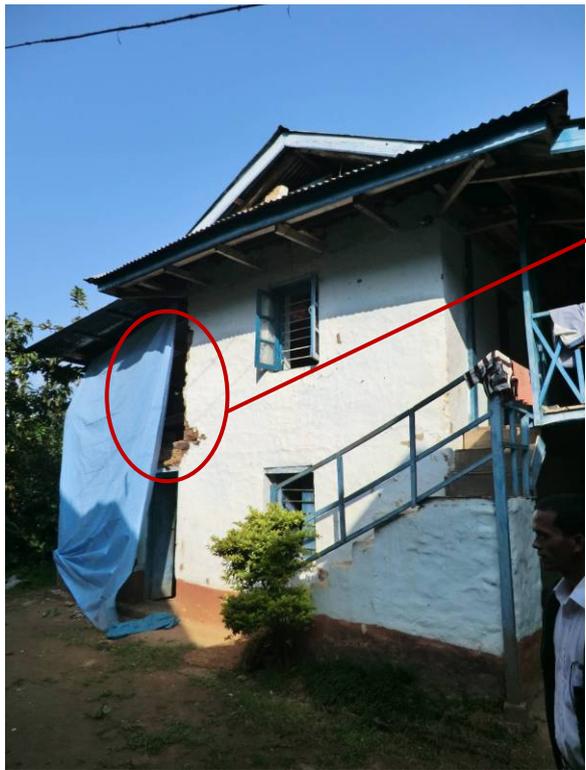
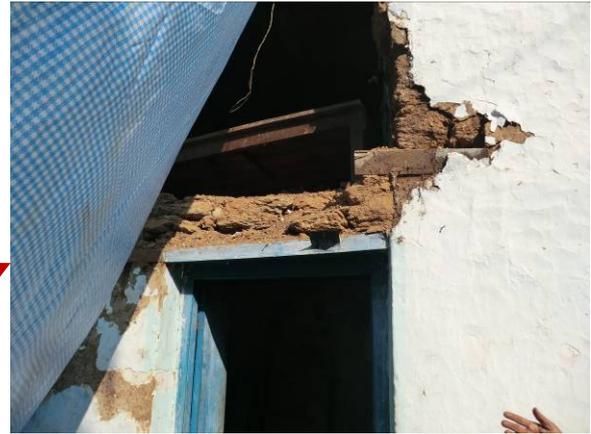
Fig. 3.8. A damaged stone masonry (mud mortar) building: (a) with collapsed wall at the front portion and (b) with collapsed wall at the back portion.

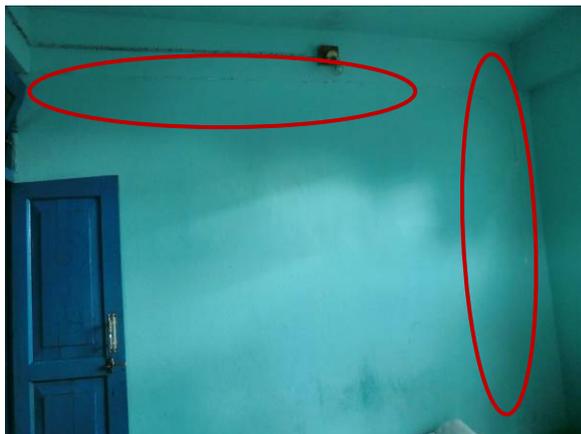
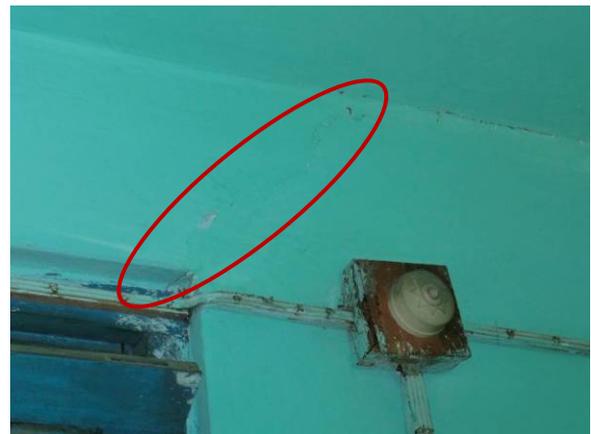
Fig. 3.9. Damage to a modern 3-story RC framed building with brick masonry infill walls: (a) separation between RC frame and wall and (b) diagonal crack starting from the corner of lintel and extending up to the floor level. The building has a length of 12.5 m and width of 8 m.

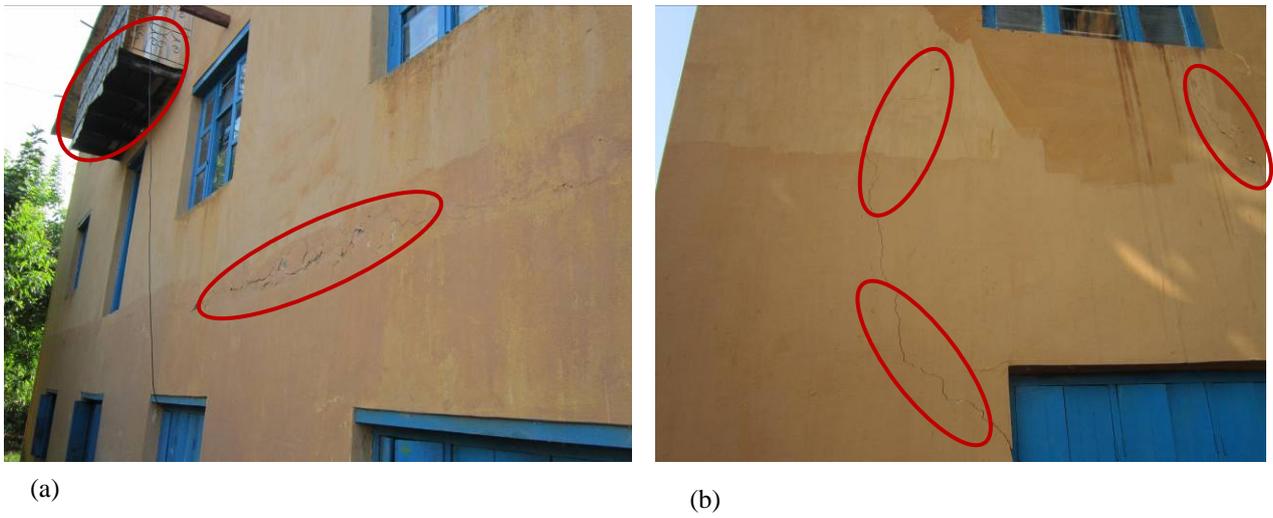
Fig. 3.10. Damage to a 25-years old building with RC as well as timber frame: (a) cantilever part in the verge of failure and crack at the floor level and (b) cracks extending between two windows of consecutive floors. The length of the building is 22 m and the width is 14 m.

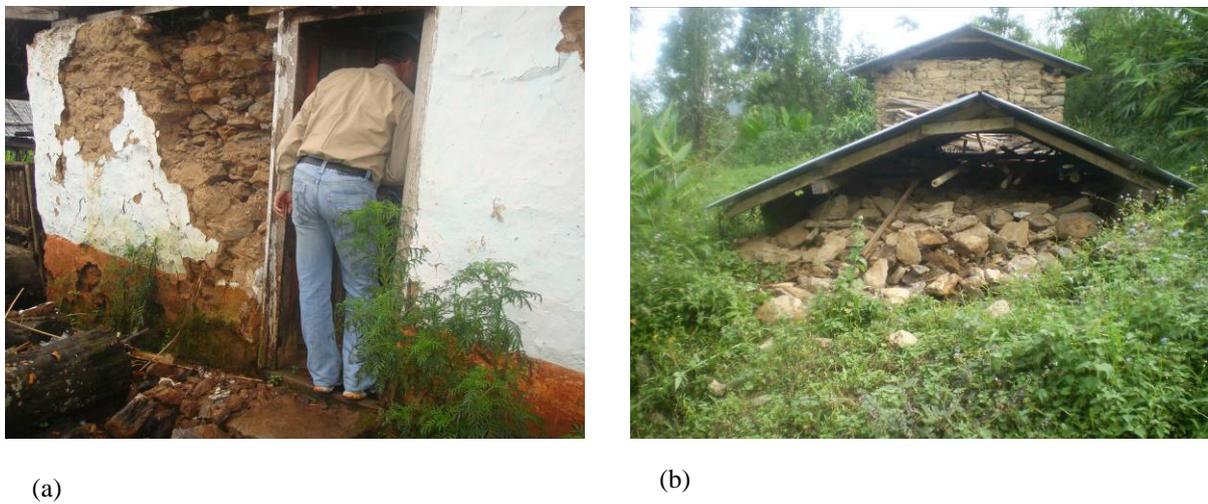
Fig. 3.11. (a) Severe damage to the wall of a stone masonry (mud mortar) building and (b) a completely collapsed building (in the foreground) and a similar building which survived without collapse (seen behind it). (Source: District Administration Office, Ilam).

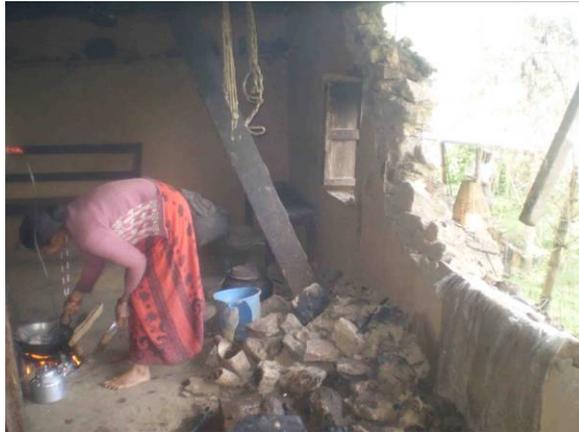
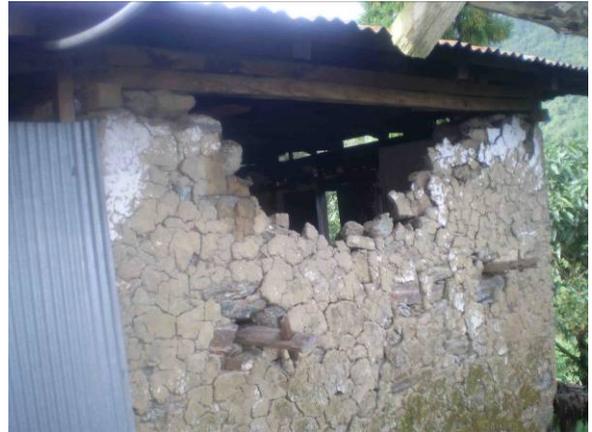
Fig. 3.12. (a) A damaged building (still being used) with collapsed wall in the kitchen and (b) a portion of the collapsed wall of a stone masonry building. (Source: Nepal Red Cross Society, Ilam).

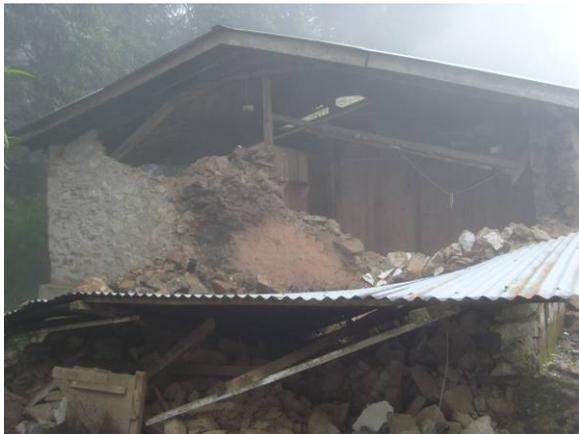
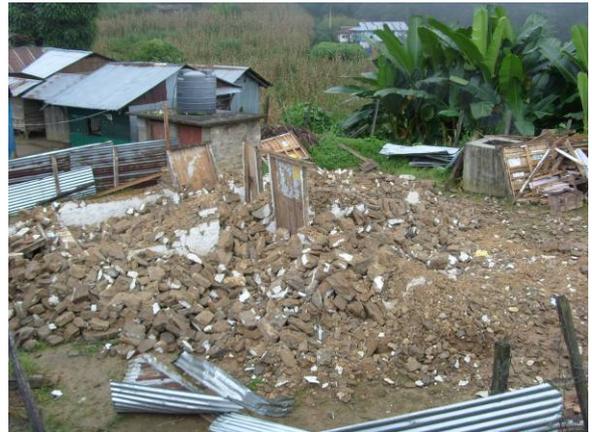
Fig. 3.13. (a) A completely collapsed stone masonry building (in the foreground) and a severely damaged building (behind it) and (b) Rubble of the collapsed building in a village. (Source: Nepal Red Cross Society, Ilam).

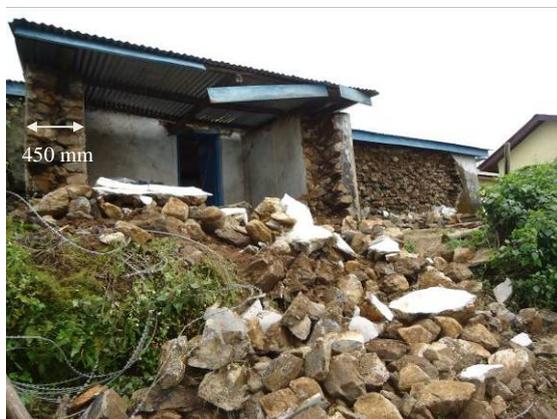
Fig. 3.14. Out of plane failure of stone masonry walls (source: Local Police). Note the 450 mm thick stone and mud mortar walls.

Buildings constructed of stone masonry with mud mortar are very weak in resisting lateral loads due to earthquakes. One of the examples of failure of such a stone masonry building is shown in Fig. 3.14, where the external wall of this small building was totally damaged due to out of plane failure and in another building, half of the thickness of the wall was torn out in out of plane direction. Not only external walls but also the partition walls also exhibited significant damages (Fig. 3.15). A complete collapse of a school building (Fig. 3.16) also illustrates the inappropriateness of stone masonry mud mortar buildings in seismic prone regions. In some buildings, stone masonry walls were used along with the timber frames in the first and second floors as shown in Fig. 3.17. The stone masonry wall was damaged during the earthquake, the timber frame system performed satisfactorily in the same building due to which the building may be used after some major maintenance in the damaged portion. However, a temple constructed of stone masonry in the first floor and timber frame system only on the second frame (Fig. 3.18) was heavily damaged. It can clearly be seen that after the collapse of the stone masonry walls, the timber posts were hanging from the roofing. Figure 3.19 shows that the presence of the steel frame and truss prevented the total collapse of the building, unlike the school building shown in Fig. 3.16,

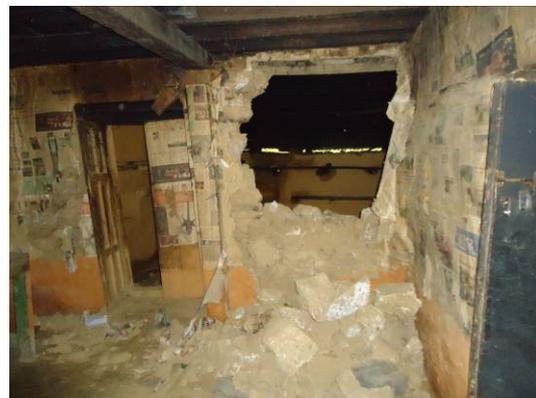
Fig. 3.15. Out of plane failure of stone masonry partition wall (source: Local Police).

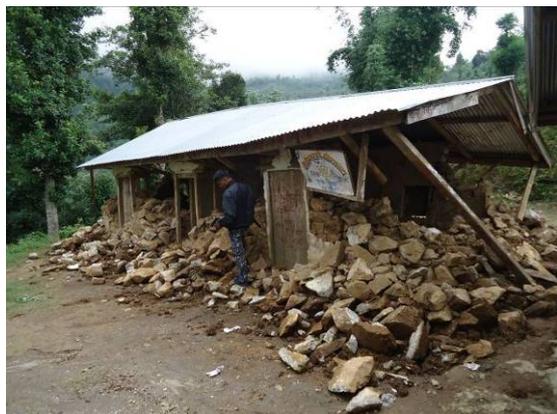
Fig. 3.16. Collapse of school building at Cheplung, Panchthar (source: Local Police).

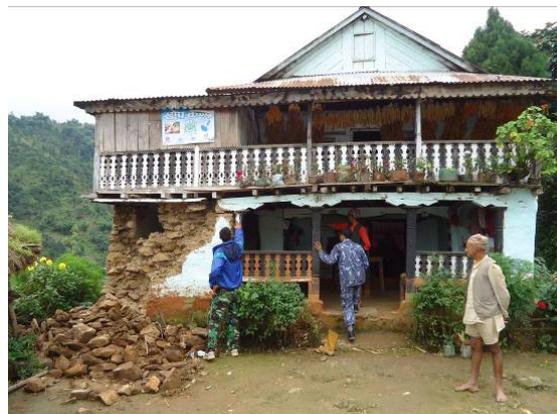
Fig. 3.17. Collapse of stone masonry wall in timber framed building (source: Local Police).

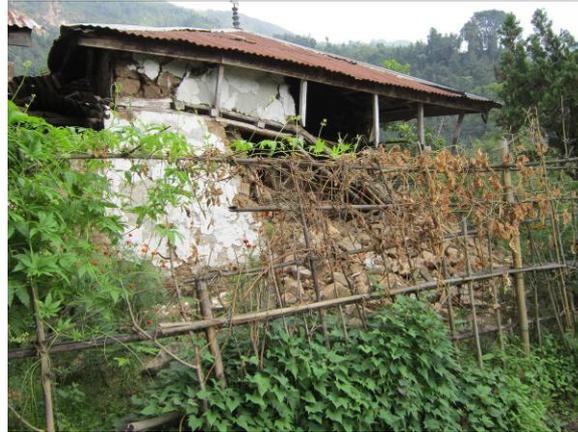
Fig. 3.18. Collapse of Laxmi Narayan Temple located north of Ranke on the road to Phidim .

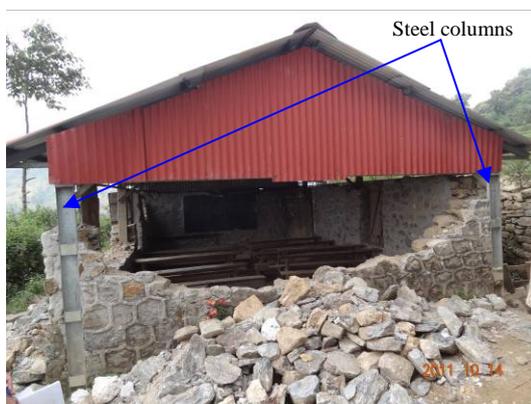
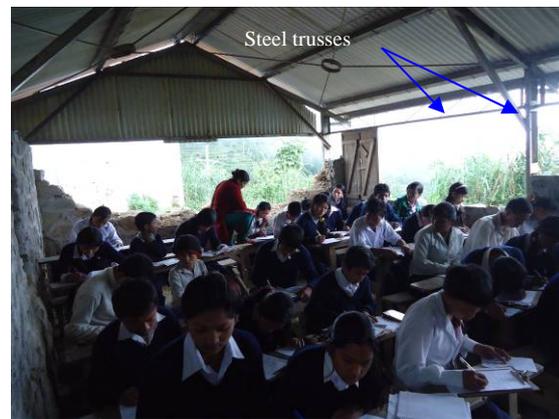
Fig. 3.19. A heavily damaged school building with: (a) collapsed wall and (b) a damaged classroom still used for classes.

though the infill stone masonry walls were heavily damaged. Due to the intact steel columns and the roofing that even after the collapse of the infill walls, the classes could be conducted in the school building. One of the poor non-engineered construction practices can be seen in Fig. 3.20. A timber building supported by some timber posts and covered with corrugated galvanized iron (CGI) sheet was constructed nearby the road. During earthquake the supporting timber posts were broken and the building toppled down leaving it upside down. Figure 3.20 was obtained from the local police in Ranke Bazar, prior to the field visit, the rubbles had already been cleared.

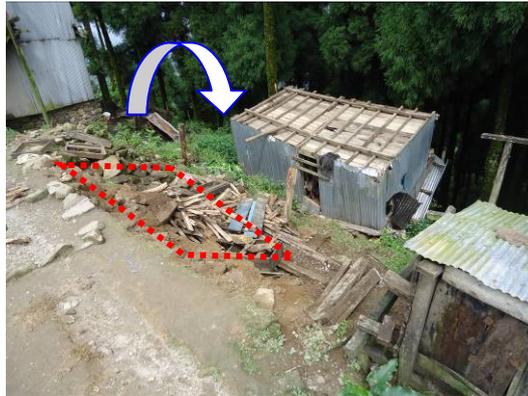
Fig. 3.20. Topped building lying upside down after the failure of supporting timber posts.

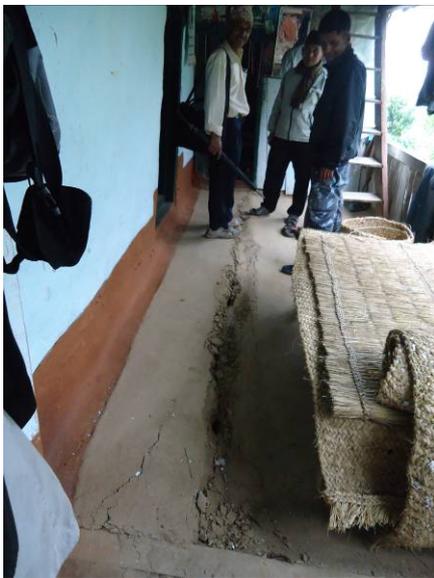
Fig. 3.21. Fissure on ground passing through the building.

Apart from damage to the buildings due to lateral seismic load, in some locations the fissures on the ground were also observed. It was interesting to note that the fissure was passing through many buildings along the road as shown in Figs. 3.21 and 3.22 causing differential settlement of the buildings (Fig. 3.23) and inducing some minor cracks in the infill walls of the RC building (Fig. 3.24).

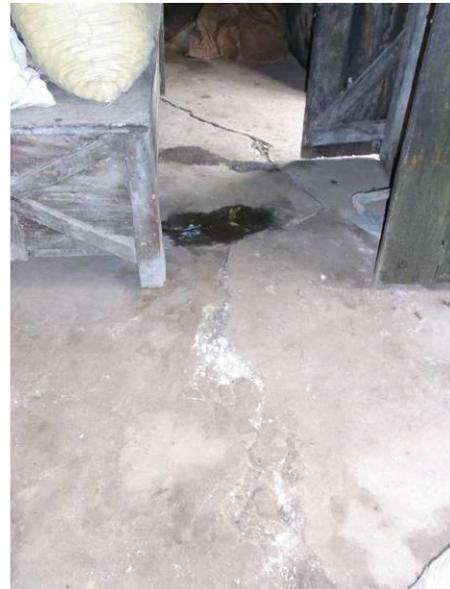
Fig. 3.22. Fissure on the ground passing through the RC framed building.

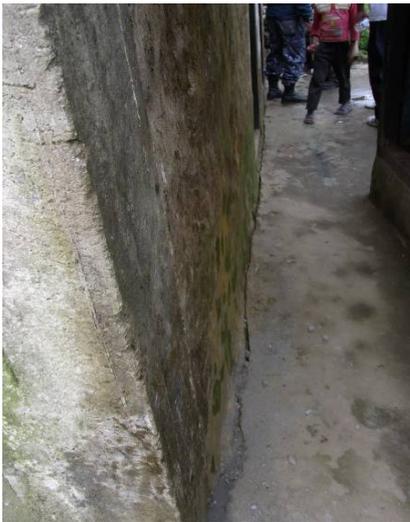
Fig. 3.23. Settlement of RC building.

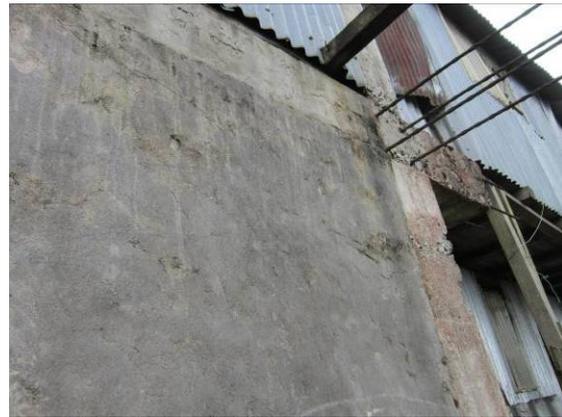
Fig. 3.24. Cracks on the infill masonry wall of RC framed building.

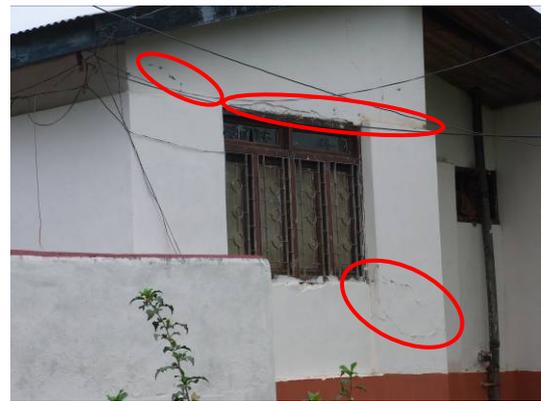
3.29), however, in the brick masonry building close to the *Centibera* building many cracks were visible in the masonry walls (Fig. 3.30). Also, the brick masonry infill walls were separated from the adjoining RC frames of the RC building (Fig. 3.31).

Fig. 3.30. Shear and flexural cracks in the brick masonry building.

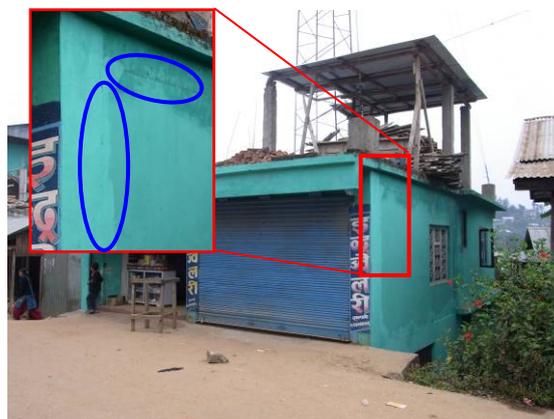
Fig. 3.31. Separation between RC frame and infill brick masonry wall.

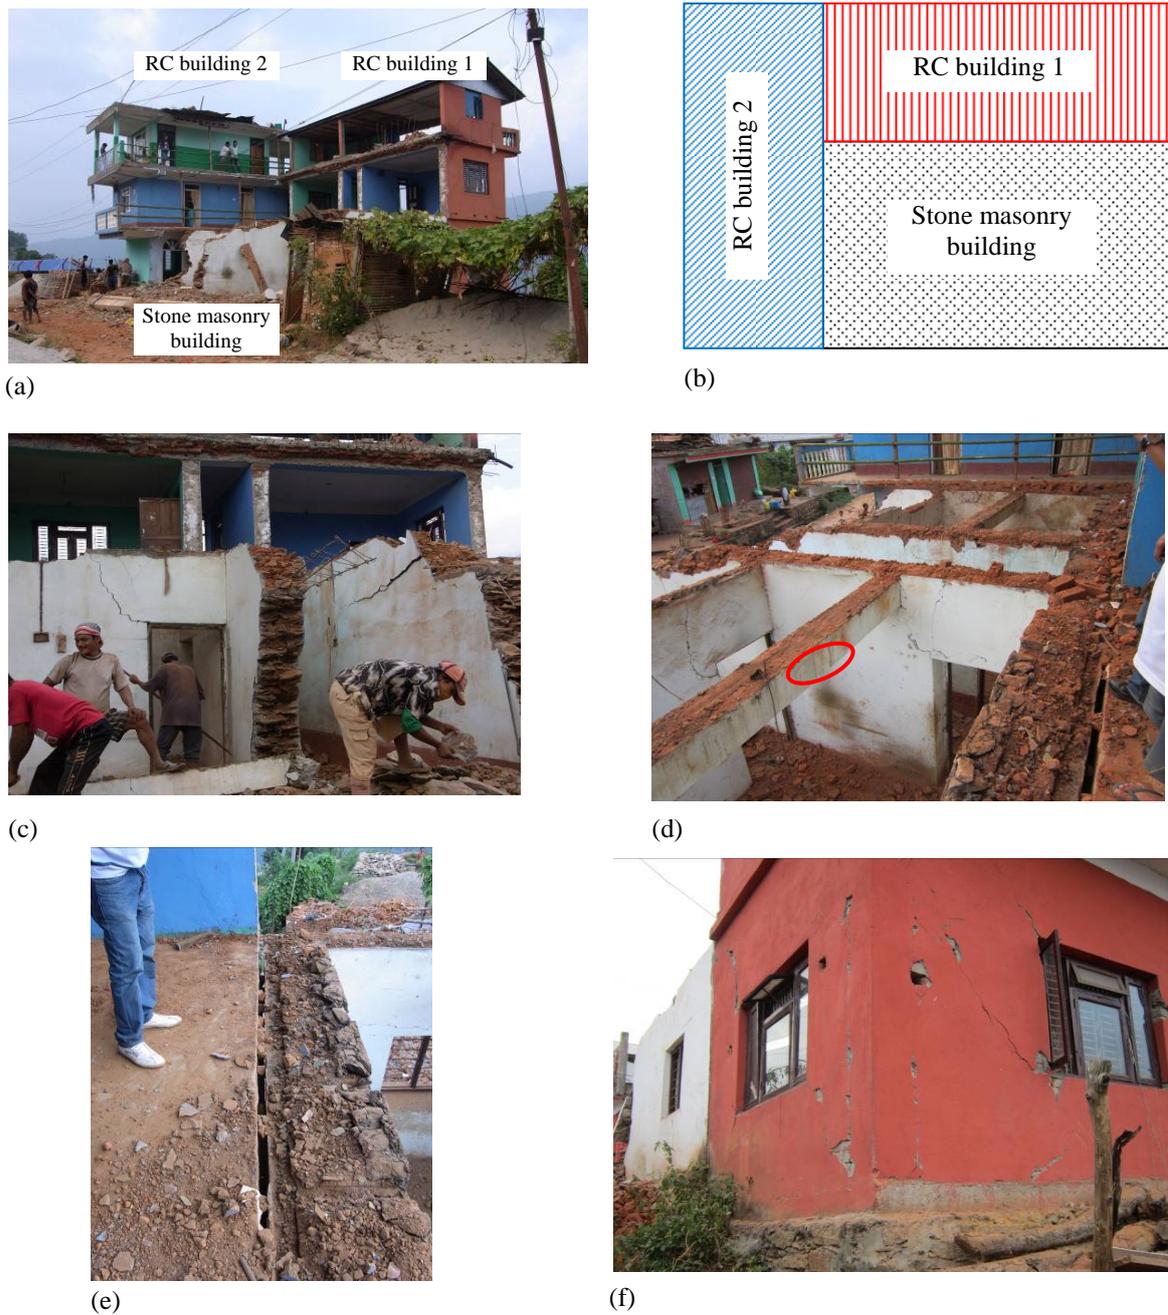
Fig. 3.32. Collapse of stone masonry building due to structural pounding: (a) collapsed stone masonry building with the two adjacent RC buildings; (b) building configuration; (c) steel rebar band provided in the stone masonry wall; (d) flexural cracks on RC beam supported by stone masonry walls; (e) residual gap between stone masonry building and RC building 1; and (f) shear cracks on both the orthogonal infill brick masonry walls of RC building.

In Phidim Bazar, a collapse of a stone masonry building due to *structural pounding* was also found. When our survey team reached at the site, the demolition of damaged stone masonry building was in progress. Figure 3.32(a) shows the three buildings without any gap between the adjacent buildings. The white colored demolished building is the stone masonry building. The configuration of the buildings is shown in Fig. 3.32(b).

The stone masonry building was constructed 20 years ago, the RC building 1 was 7 years old and the RC building 2 was recently built. The stone masonry building was of 2 story and

other adjacent buildings were 3 storied buildings. The provisions of steel rebar band in the stone masonry wall (Fig. 3.32(c)) and RC tie beams on top of walls (Fig. 3.32(d)) were the peculiar features of this masonry building. During the entire field survey, in no other stone masonry buildings such provisions were observed. However, being constructed with mud mortar and attached with other two RC buildings, the stone masonry building could not withstand the seismic load and the impact loads from the adjacent buildings. During the earthquake, the second floor walls including the roof of the masonry building were completely collapsed dumping the rubbles on the first floor slab. Due to excessive load, some of the RC tie beams failed in flexure. Permanently deflected beam with many flexural cracks at the mid span of the beams were clearly visible (Fig. 3.32(d)). Also, there existed permanent gap of about 5 cm (Fig. 3.32(e)) between the stone masonry building and RC building 1 though there was no gap before the earthquake.

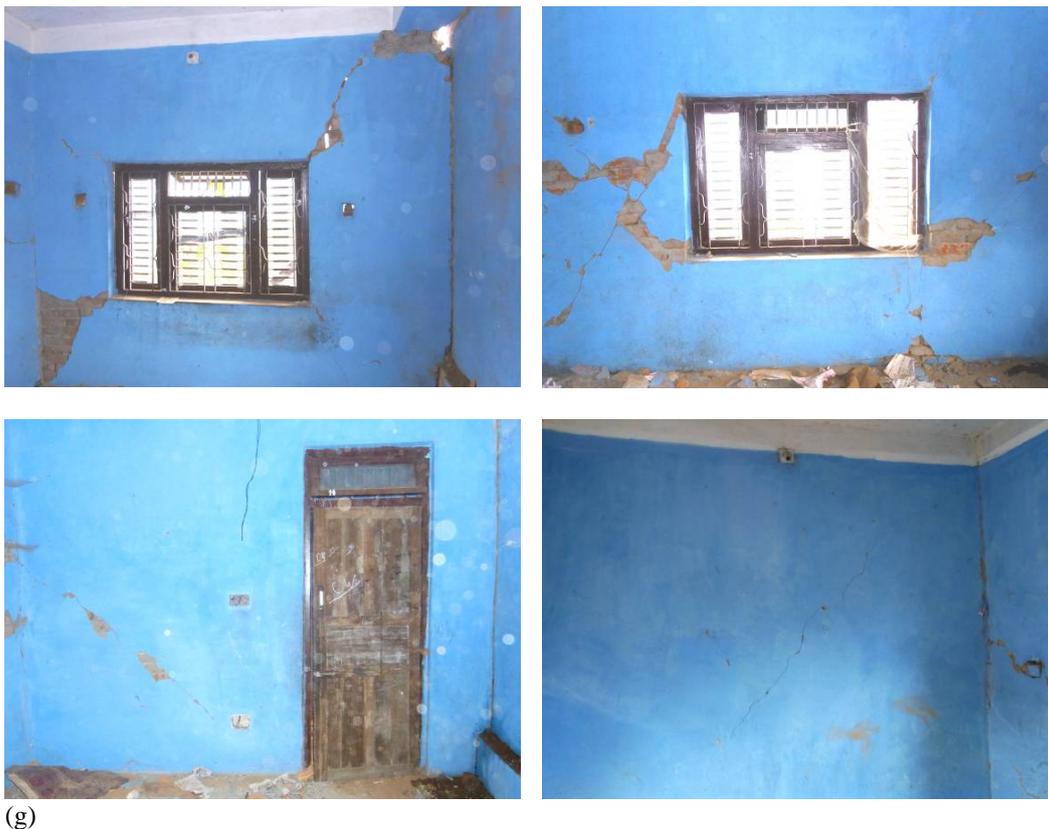
Fig. 3.32. Collapse of stone masonry building due to structural pounding: (g) cracks on all four walls of a room in RC building 1.

RC building 1 also suffered heavy damage. The brick masonry infill wall at the third floor was completely collapsed. Hence, only the bare frame was visible at the third floor in Fig. 3.32. In most of the cases, the shear cracks are formed in one direction of the masonry walls, however, in RC building 1, shear cracks were generated in all the four orthogonal walls of the building as shown in Fig. 3.32(f). It was believed that the shear crack in one direction of wall was due to the earthquake load and that in another direction was attributed by the shear force exerted by the structural pounding between the buildings. In the rooms at the first floor of the RC building 1, shear cracks were clearly visible in all the surrounding four walls as depicted in Fig. 3.32(g).

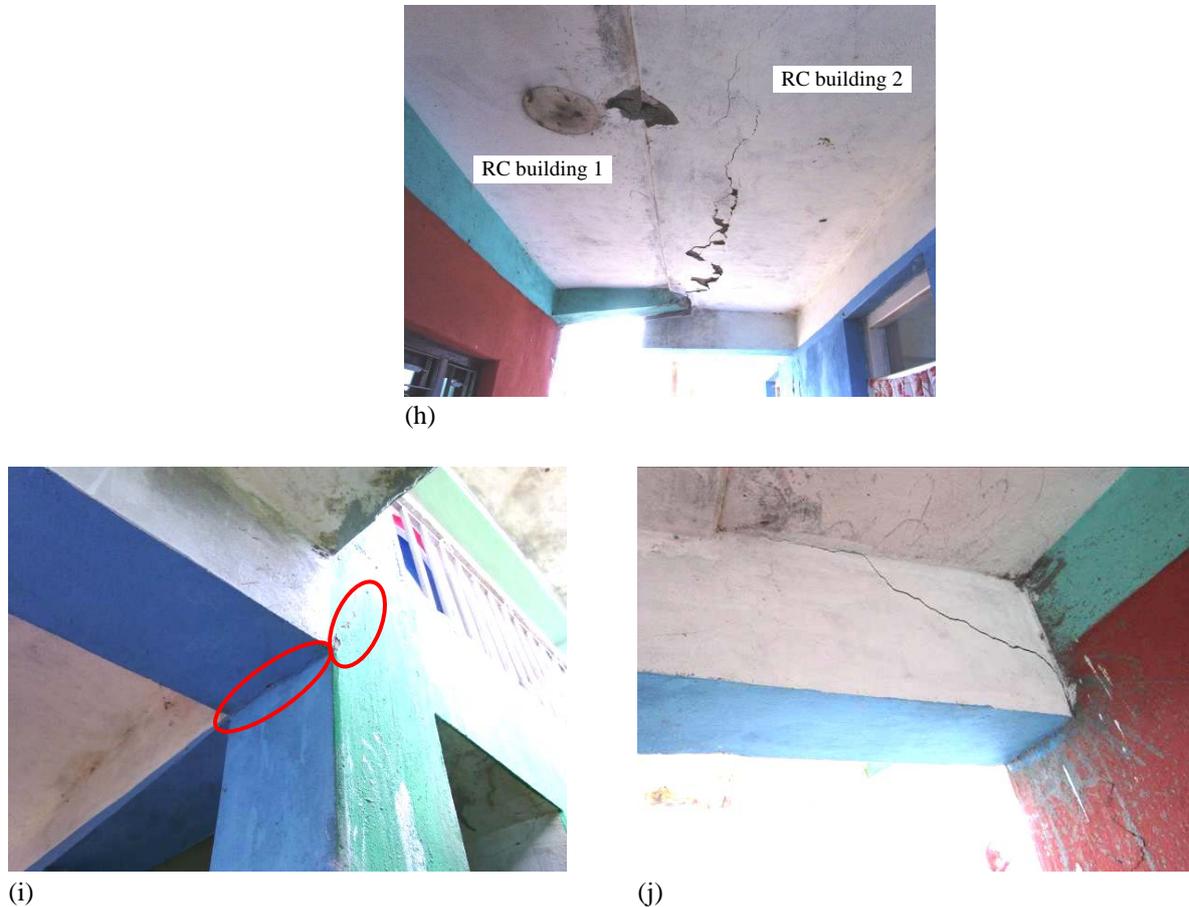
Significant amount of cracks were developed in the slabs of RC building 1 and RC building 2 (Fig. 3.32(h)) as a result of structural pounding between RC building 1 and RC

building 2. Also, the structural pounding caused the formation of shear cracks at the beam-column joint (Fig. 3.32(i)) and a beam of RC building 2 (Fig. 3.32(j)). Hence, the damages on these three buildings shows one of the good examples of structural pounding and also illustrates the vulnerability to structural pounding of buildings, if the provided gap between the adjacent buildings are insufficient.

Fig. 3.32. Collapse of stone masonry building due to structural pounding: (h) induced cracks on the slab of RC building 2 due to structural pounding; (i) shear cracks in the beam-column joint; and (j) shear crack on the beam.

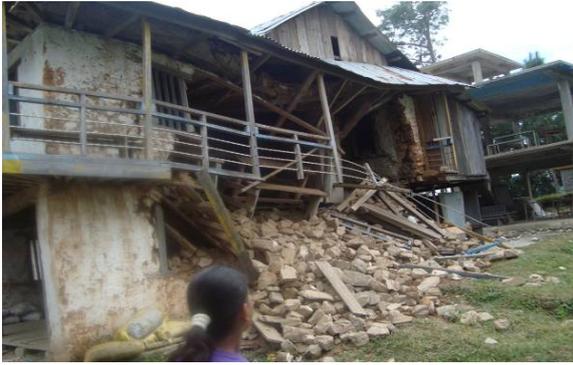
Fig. 3.33. Collapse of school building (source: Red Cross, Taplejung).

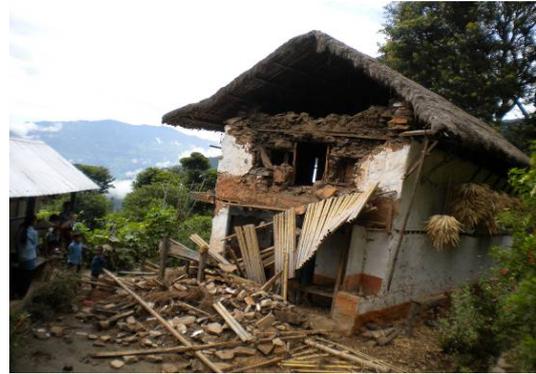
Fig. 3.34. Collapse of stone masonry building (source: Red Cross Taplejung).

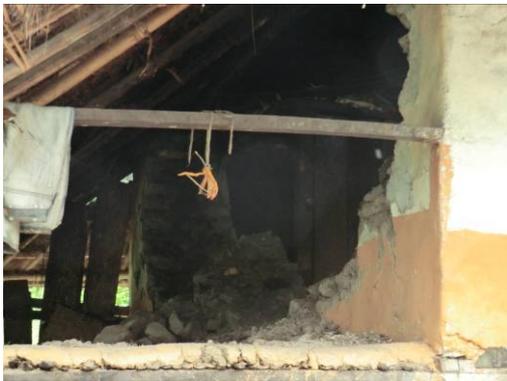
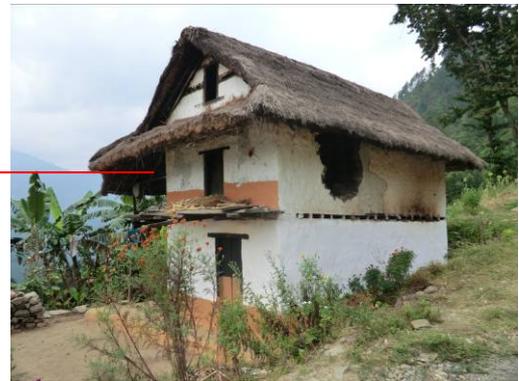
Fig. 3.35. Out of plane failure of stone masonry wall.

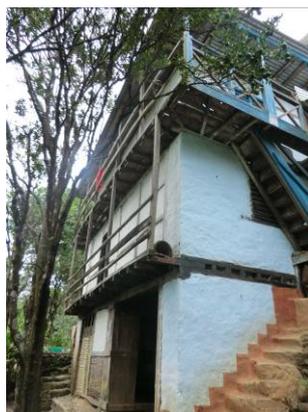
Fig. 3.36. Cracks occurred in stone masonry wall but no cracks in *Centibera*.

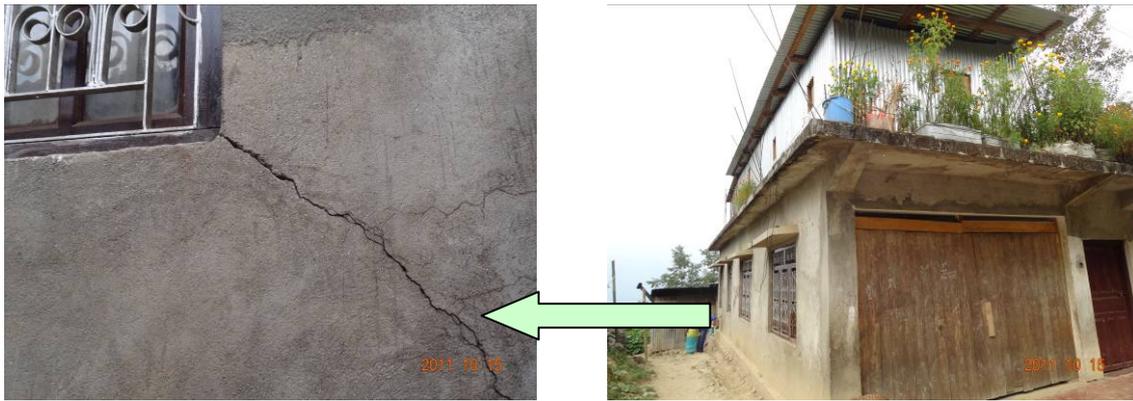
Fig. 3.37. Shear cracks in the infill brick masonry wall of RC building.
