# CUEE Report 2011-2

## **INITIAL SURVEY RESULTS: 2011 TOHOKU PACIFIC EARTHQUAKE**

Center for Urban Earthquake Engineering (CUEE), Tokyo Institute of Technology

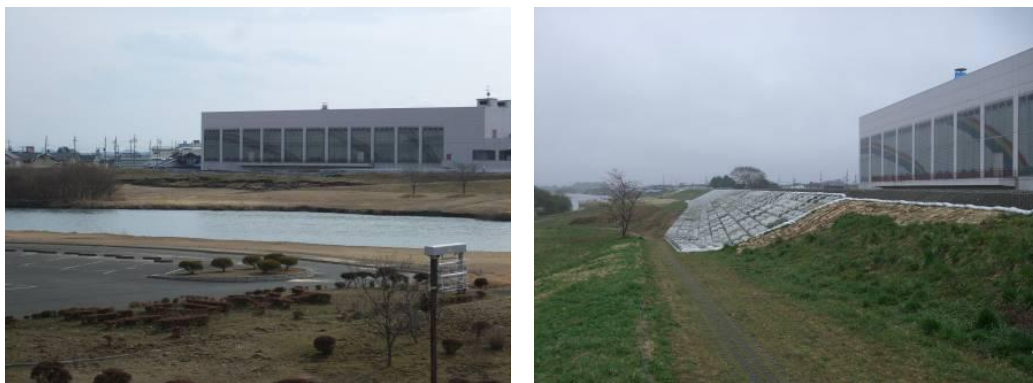
River levees may be damaged by liquefaction in two ways: one pattern involves liquefaction at the foundational level, while the other results from liquefaction of the lower portion of the levee itself. The former is a typical form of earthquake-induced damage to levees, which occurs when foundation ground has liquefied to such an extent it can no longer support the levee, causing settlement or resulting in longitudinal cracks. Photo 1 shows one such example. A levee along the Eai River, which was built on land reclaimed from a former river channel, settled due to liquefaction. At the same time, several broad longitudinal crevices more than 2 meters deep were formed. Along the former river channel, which stretches from the site depicted in the photo to the Shin-Eai River to the south, sand boiling and resultant uneven settlement of houses were observed in many places. Emergency repairs removed paving and brought in provisional fill, with the slopes protected by articulated concrete mats. When the author visited the area for the second time after the earthquake, the emergency repair work dating to April 4, 2011, had already been completed.

**Photo 1: Levee along the Eai River having subsided due to liquefaction of its foundation (At Furukawa-Fukunuma in Osaki City, Miyagi Prefecture: Right Levee at River Kilometer 26.8). Left: before repairs (view from opposite bank, March 14, 2011); Right: after restoration (April 22, 2011)**

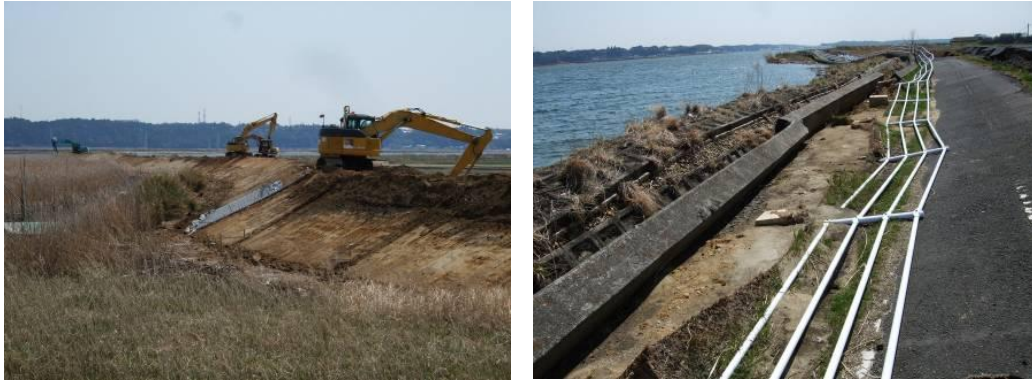
The second common pattern of damage normally occurs where a foundation consists of clay or other types of soft soil that do not liquefy, yet where such ground has subsided considerably over time as a result of levee construction, leaving the lower level of the levee exposed to liquefaction. This pattern has only rarely been reported in past earthquakes, but occurred in several different places in the course of this year's March earthquake. Photo 2 shows an example. The levee built to protect reclaimed land settled more than 1 meter, producing a number of wide, longitudinal cracks. The site's clay foundation was approximately 10 meters deep and apparently did not liquefy. The main cause of damage, therefore, must have been liquefaction of the levee itself.

**Photo 2: Levee along the Hinuma River having subsided due to its liquefaction. (At Shimoishizaki in Ibaraki town, Ibaraki Prefecture: Left Levee at River Kilometer 8.) Left view: damaged area of section under prefectural management; right view: repairs undertaken by central government. (Both April 13, 2011.)**

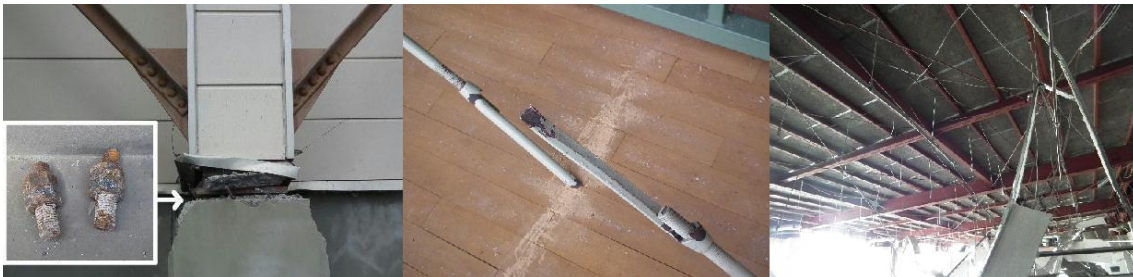
Photos 1 to 3 show examples of damage to a school gymnasium. Photo 1 exhibits damage to a column base, where anchor bolts connecting the column to its foundation extended and ruptured. These had apparently been designed as pin connections. However, when a building is deformed by seismic force, any column base will rotate significantly, exerting a strong pull-out force on its component anchor bolts. Even if such bolts are assumed to perform as part of a pin joint assembly, some degree of bending will apply, resulting in plastic deformation. At points where bracing is connected, the bolts also receive strong pull-out and shearing forces from brace elements.

This type of damage has been seen in major earthquakes in the past. But even after the major Japanese seismic standards revision of 1981, cases have been observed in which insufficient attention was paid, in the design and building of column bases, to the external force that is likely to affect column bases or to the deformation capacity of the anchor bolts. Photo 2 depicts a sheared seismic brace. At this gymnasium, no glass was broken, yet even before the structure had undergone major deformation, turnbuckles were loosened and came apart.

**Photo 1: Column base damage  
at a school gymnasium**

**Photo 2: Broken brace  
element from the same gym**

**Photo 3: Fallen ceiling panel  
at an adjacent building**

Photo 3 shows a fallen ceiling panel at a building adjacent to the same gym. In many other gymnasiums, ceiling panels also fell down. In addition, a number of reports have also been filed on damage to nonstructural elements, such as displacement of non-bearing outer walls.

Thus, some of the observed damage involved issues with seismic elements or connector capacity, as seen here. These examples come as a strong reminder of the importance of fundamentals. Any building needs to be designed in ways that ensure quake-induced damage will occur mostly in places where repair and replacement are easy to implement. Similarly, new design methods to render seismic elements and connectors easier to understand must be promoted, so that each and every component possesses sufficient seismic capacity.

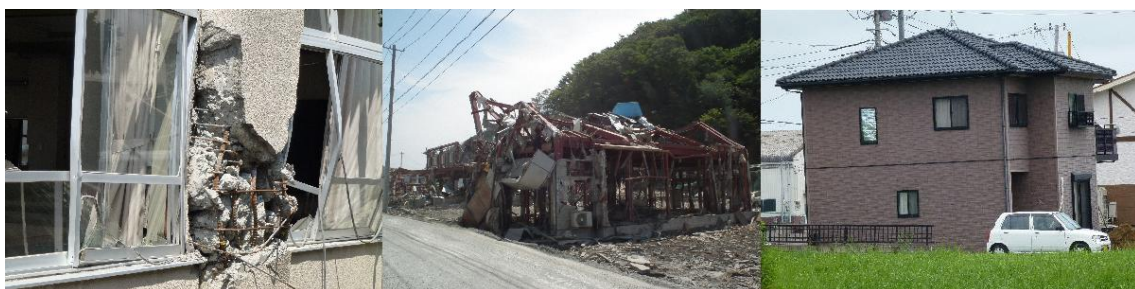
Photo 4 shows a classroom building where a column has suffered shear rupture. Damage to school facilities was by and large seen in cases dating to the pre-1981 revision of standards, and where the needed retrofitting had not yet been carried out.

In areas hit by the tsunami, on the other hand, whole communities were destroyed. A number of reinforced concrete structures appear to have held firm, but the tsunami swept timber-framed structures away and often gutted steel-frame units. In coastal areas directly hit by the force of the tsunami, steel frames were seen bent as if they were soft materials (Photo 5), proof, if needed, of the unimaginable magnitude of this tsunami.

Furthermore, soil liquefaction caused damage at reclaimed sites, as exemplified by the tilted residence depicted in Photo 6. Frequently, ground settlement also occurred, underscoring a need to improve subgrade support for structures in numerous areas.

**Photo 4: Damage to reinforced-concrete school facility**

**Photo 5: Steel frame structure gutted and deformed by tsunami**

**Photo 6: House tilted due to soil liquefaction**

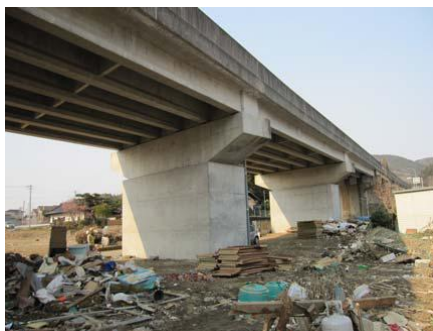
**Photo 1: Intact piers of Shishiori Viaduct at Kesenuma, shown post-submersion**

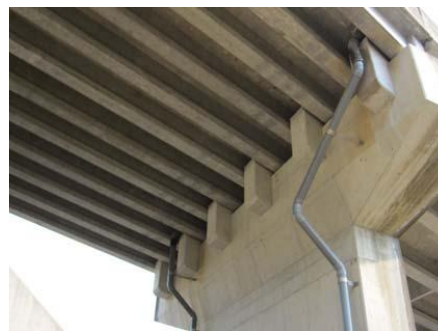
Let us cite a few specific examples in coastal districts. Several bridges under central government management collapsed—all of these belonged to coastal segments and were hit by the tsunami. Other bridges, even though impacted by the tsunami, escaped damage where this impact was less severe. The Shishiori Viaduct at Kesenuma, Miyagi Prefecture, for example—although its piers were completely submerged—suffered no apparent damage (Photos 1 and 2). The structure's main girders are interconnected and its piers reinforced by the wrapping method.

**Photo 2: Main girders interconnected and piers reinforced by wrapping method**

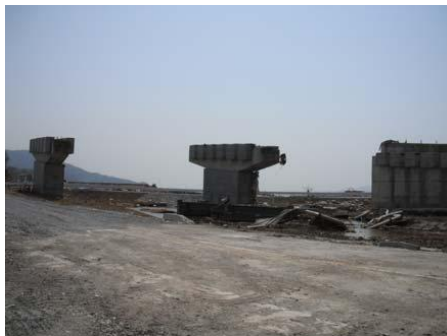
The Numata Bridge crossing a railway at Rikuzentakata, Iwate Prefecture, however, lost all three main girders, which were simple post-tensioned, pre-stressed concrete T-shaped girders (Photos 3 to 6). As Photo 5 shows, the bridge's unseating prevention devices remain nearly intact. As recorded in Photo 6, anchor bars connecting the pier-supported main girders remained unbent. These observations suggest that the tsunami first pushed these girders up off their respective piers before sweeping them away.

**Photo 3: Numata Bridge at Rikuzentakata having lost all three main girders**

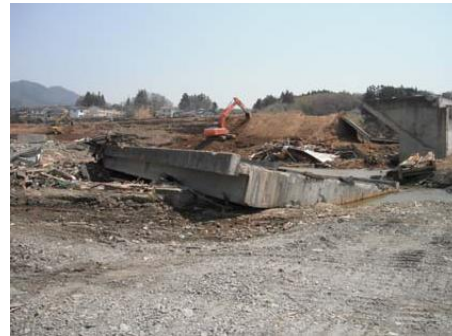
**Photo 4: Fallen girders at Numata Bridge**

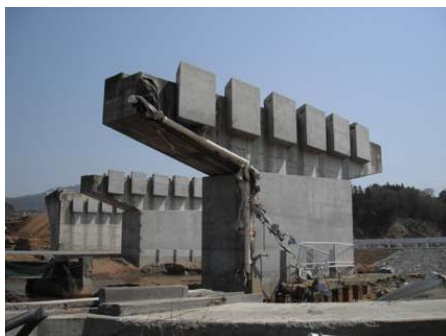
**Photo 5: Unseating prevention systems in Numata Bridge nearly intact**

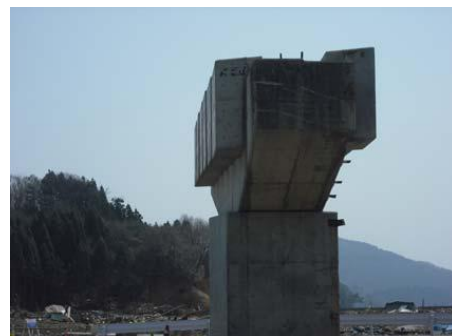
**Photo 6: Anchor bars remain upright in Numata Bridge**

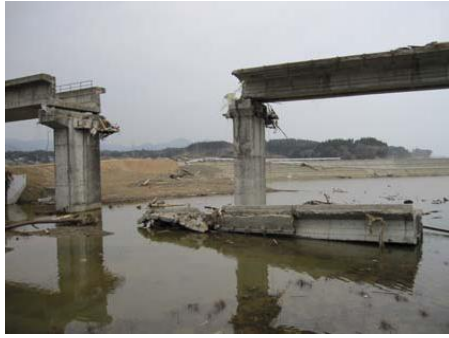
Meanwhile, railway bridges along local lines in coastal districts suffered severe damage. Several bridges on the JR Kesenuma Line were destroyed, involving some girder displacement and pier collapse. Girder displacement and fall were apparently caused by the tsunami (Photo 7). Pier displacement in Photo 8 was likely triggered as tsunami waters scoured the riverbed; however, the broken pier in Photo 9 suggests insufficient seismic strengthening.

**Photo 7: Fallen girder at the  
Sodeo-gawa Bridge  
(JR Kesenuma Line)**

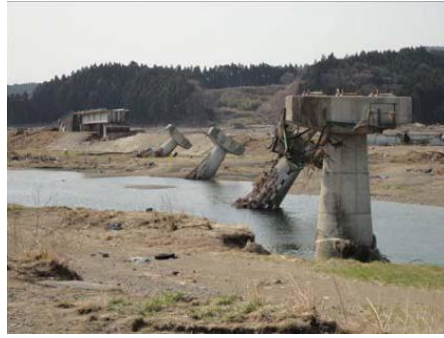
**Photo 8: Collapsed piers of  
Tsuya-gawa Bridge  
(JR Kesenuma Line)**

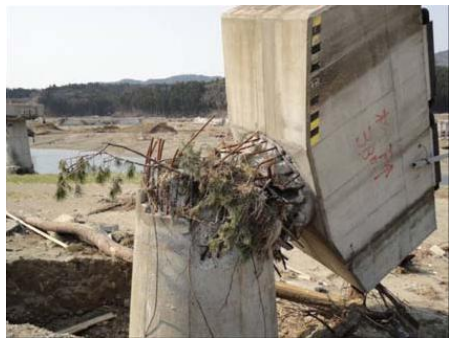
**Photo 9: Broken pier of Tsuya-gawa  
Bridge  
(JR Kesenuma Line)**
