A METHOD TO EVALUATE THE SAFETY OF THE EXISTING PILED FOUNDATIONS AGAINST BUCKLING IN LIQUEFIABLE SOILS

S. Bhattacharya

Abstract: Recent research into the pile failure mechanism has shown that there is a fundamental omission in the seismic pile design in liquefiable areas. The current codes of practice for pile design such as EC 8, NEHRP 2000, JRA1996 and IS1893 is based on a bending mechanism where lateral loads due to inertia or slope movement induces bending failure in the pile. These codes omit considerations necessary to avoid buckling of a pile due to the axial load acting on it at all times in an event of soil liquefaction due to the diminishing soil support. These codes are inadequate and buckling needs to be addressed. Bending and buckling require different approaches in design. Bending is a stable mechanism and is dependent on strength whereas buckling is dependent on geometric stiffness and is almost independent of strength. Designing against bending would not automatically suffice the buckling requirements. For pile design, to avoid buckling there is a need to have minimum diameter depending on the depth of liquefiable soil. Thus there is a need to reconsider the safe

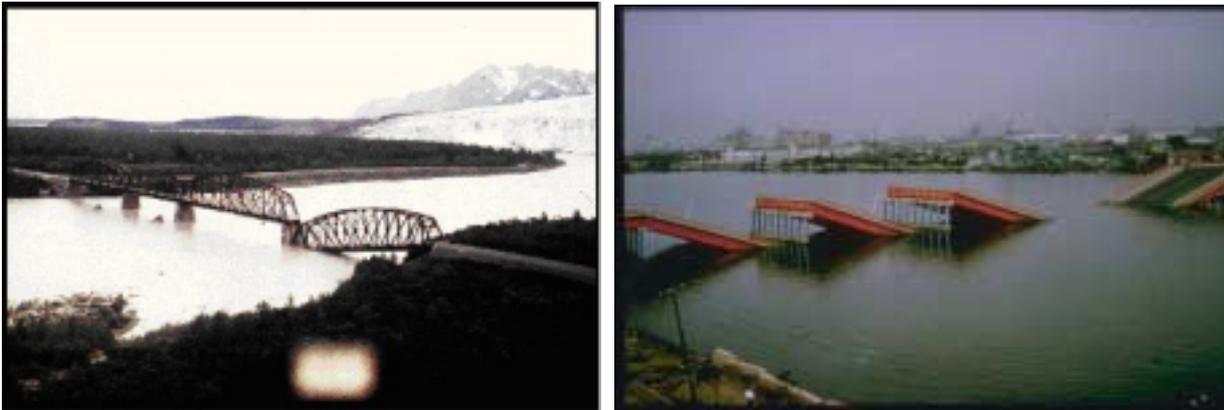
It is a common observation in seismic bridge failure that piers collapse while abutments remain stable, for example Figures 1 (a&b). Figure 1 (a) shows the collapse of one the piers of the Million Dollar Bridge leading to bridge failure. Similar failures were also observed of the Showa Bridge during the 1964 Niigata earthquake; see Figure 1(b).

Figure 1: Failure of bridges in earthquakes; (a): Million Dollar Bridge after the 1964 Alaska earthquake; (b): Showa Bridge after the 1964 Niigata earthquake. Photo courtesy NISEE.

Bhattacharya (2003), Bhattacharya et al (2004b), Bhattacharya and Bolton (2004a) studied in-depth the well known failure of the Showa Bridge, see Figure 1(b). This bridge was only one month old when the earthquake of Niigata occurred and the bridge collapsed. Details of the failure can be seen in Hamada (1992), Takata et al (1965), and Ishihara (1993). This bridge was studied in-depth as the bridge had steel tubular piles and was only one month old when it collapsed. Thus it is unlikely that the material of the pile corroded and it can be used as a benchmark problem for validation and verification of hypothesis or mechanisms. Figure 3 shows the schematic representation of the failure of the bridge which can be compared with Figure 1(b). As can be seen from Figure 3, piles under pier no. P₅ deformed towards the left and the piles of pier P₆ deformed towards the right, Takata et al (1965). Had the cause of pile failure been lateral spreading, the piers should have deformed identically in the direction of the slope. Furthermore, the piers close to the riverbanks did not fail, whereas the lateral spread is seen to be most severe at these places.

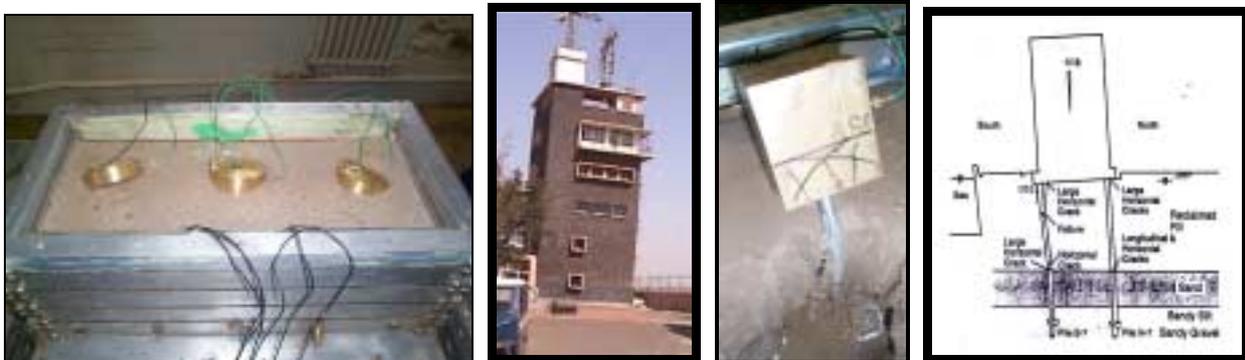
Figure 6: Model test and field case history; (a): Pile foundation after the dynamic centrifuge test; (b): Failed Kandla Port tower; (c): Hinge formation in the centrifuge test; (d): Hinge formation in a building, Tokimatsu et al (1997).
