# CUEE Report 2011-2

## **INITIAL SURVEY RESULTS: 2011 TOHOKU PACIFIC EARTHQUAKE**

Center for Urban Earthquake Engineering (CUEE), Tokyo Institute of Technology

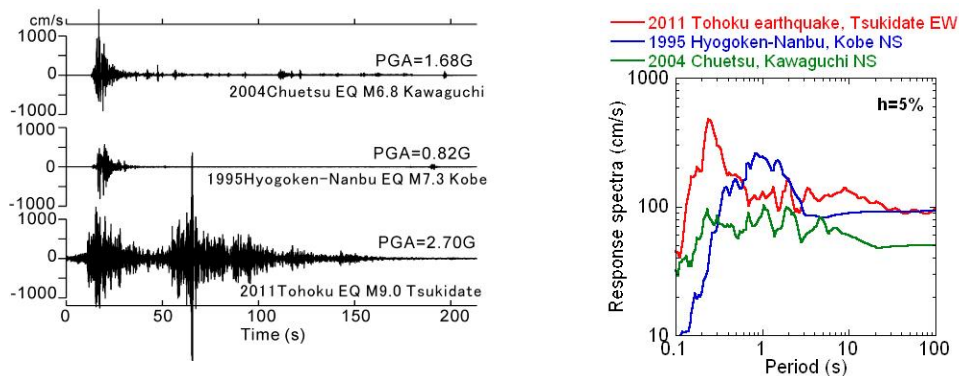
The maximum intensity of 7 (on the Japanese seismic intensity scale of 0 to 7) was observed at more than one location during the March 11 quake. One such is Tsukidate in Miyagi Prefecture, where a peak ground acceleration of 2.7G was recorded. As Figure 3 shows, an acceleration of far larger than 2G was recorded briefly at the beginning of the second wave packet. But there was no major damage involving collapsed buildings in the neighborhood of the Tsukidate strong motion station. Also shown in Figure 3 are acceleration time histories of the Hyogoken-nanbu Earthquake that hit the city of Kobe and its vicinity in 1995 (recorded at Kobe) and the Chuetsu Earthquake of 2004 (recorded at Kawaguchi town, Niigata Prefecture), both of which marked an intensity of almost 7. It becomes notably clear how strong and how long the March 11 jolt was when compared with these earlier records. Figure 3 also presents a comparison of velocity response spectra of these three major quakes, underscoring the fact that short-period components of around 0.2 second were conspicuously predominant at Tsukidate. Periodic components of approximately 1 second were greater in the Hyogoken-nanbu Earthquake. These differences in periodic components likely explain why the March 11 quake did not cause great damage in the Tsukidate neighborhood (Sakai, 2001, and other recent reports).

**Figure 3: Acceleration time histories of past strong motions and a comparison of velocity response spectra**

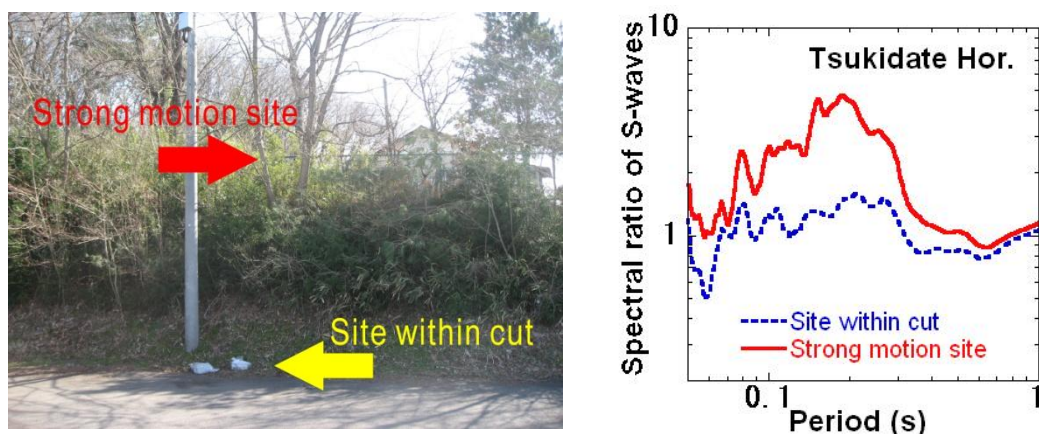
To gain a better understanding of what caused those short-period seismic ground motions, we continued to observe aftershocks in the neighborhood of the Tsukidate station. As the photo in Figure 4 shows, the strong motion station is located at the edge of a cut. Also shown here are spectral ratios of S-waves for firm soils obtained from aftershock records at sites above and within the cut. The site within the cut, where shallow, surface soils have been removed, shows a rather flat spectral ratio. Above the cut, by contrast, short-period components were predominant just as in the main shock. Normally, nonlinear soil response gives rise to certain differences between a main shock and any aftershocks, but it is believed that at the Tsukidate strong motion station, short-period components were greater under the influence of shallow soils.

Figure 4: Tsukidate strong motion site and its neighborhood, and spectral ratios of aftershocks for firm soils

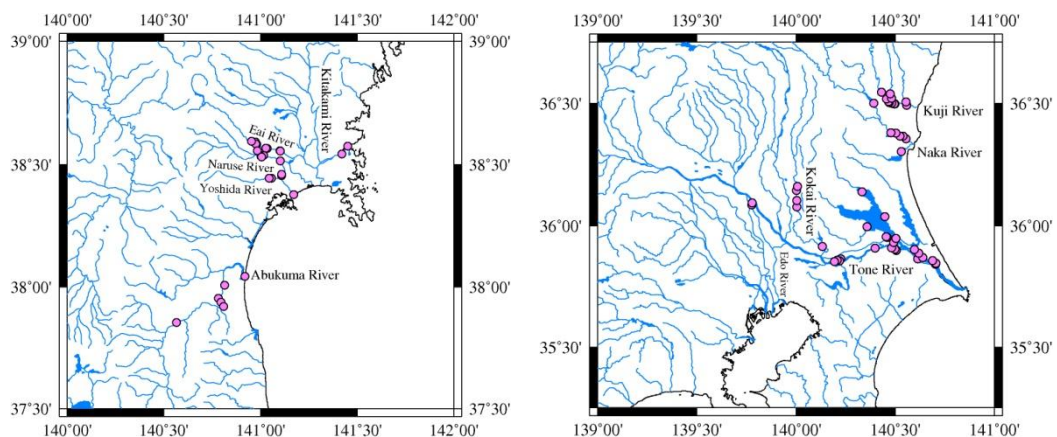
Levees suffered damage from earthquake-induced liquefaction in wide areas along the Pacific coast in the Tohoku and Kanto regions of northeastern Japan. Figure 1 shows locations at which emergency repair work was carried out at levees along major rivers under direct management of the central government. In the Tohoku region, damage was especially conspicuous in the Osaki plain (an alluvial plain formed by flooding of the Naruse and Eai rivers) in northern Miyagi Prefecture. In the Kanto region, the lower reaches of the Kuji, Naka and Tone rivers were all notably affected.

**Figure 1: Sites where emergency levee repairs have been carried out along rivers managed directly by the central government (Left map: Tohoku region; right map: Kanto region)**

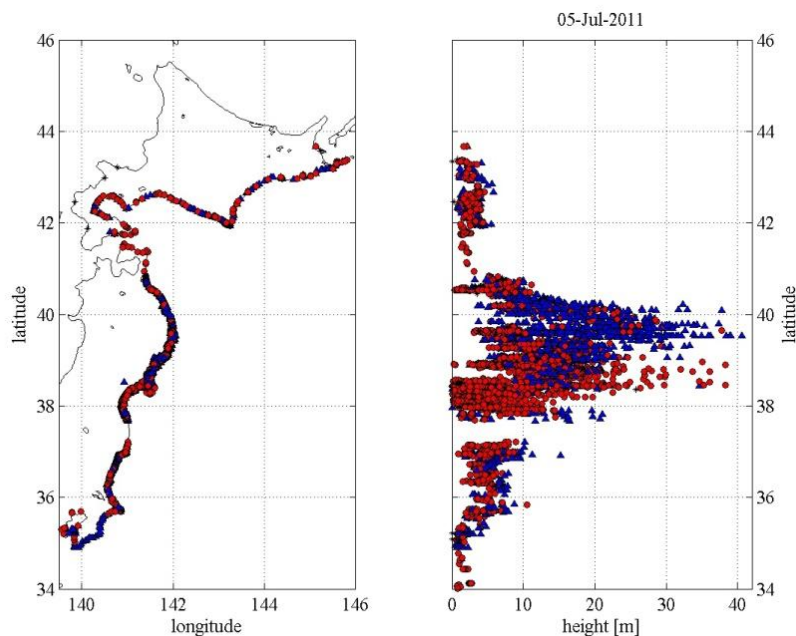
**Figure 1: Distribution of tsunami run-up and inundation heights (The 2011 Tohoku Earthquake Tsunami Joint Study Group [2011]). Blue triangles indicate run-up heights; red circles show inundation heights.**

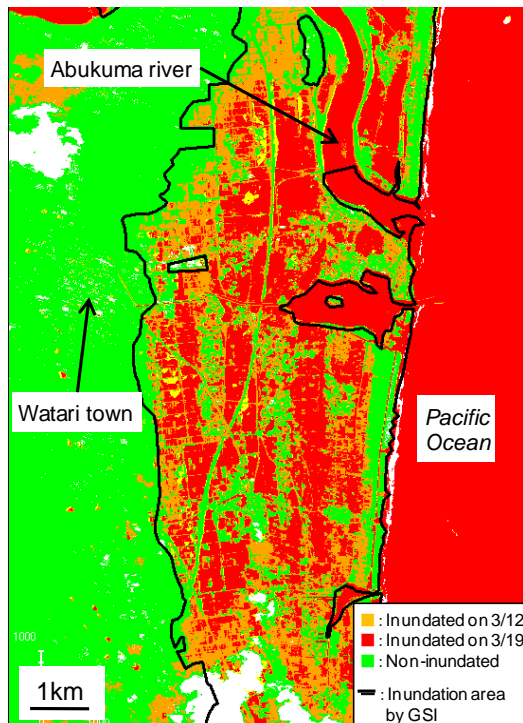
**Figure 2: Tsunami inundation areas estimated from high-resolution satellite images on two separate occasions a week apart.**

The map in Figure 2 depicts the coastal area of Watari town in the Sendai plain, in Miyagi Prefecture; inundation areas estimated from the images captured on March 12 and 19 are superimposed. Areas estimated submerged on either March 12 and 19 are shown in orange and in red, respectively. The green area shows non-inundated land, and white indicates cloud cover on one of these days.

Solid lines in the same figure refer to inundation areas estimated by the GSI through interpretation of aerial photos and other miscellaneous types of data. These lines suggest that the tsunami produced flooding as far inland as 5 kilometers from the coast. Estimates based on satellite images almost match GSI results, and this correlation strongly suggests that the NDWI is indeed effective in estimating inundated areas. The map in Figure 2 also shows that the inundated areas as of March 19 (approximately one week after the tsunami) still remained much the same as on March 12, indicating that the waters had scarcely receded. In this way, satellite images from different dates can be used to trace submersion rates over time.
